# Lee Business Area - Delivery and Servicing Plan (DSP)

## Report

**The London  
Borough of  
Lewisham**

**March 2011**

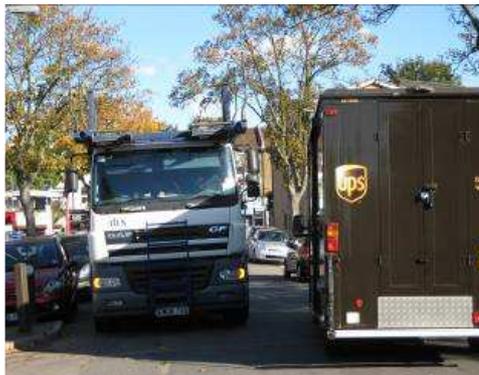
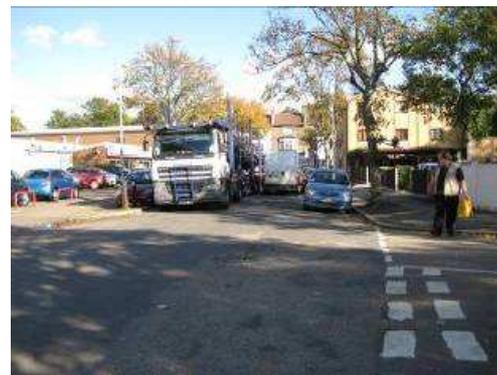
**Figures 2.1(a) and 2.1(b): Car carrier delivering to Citroën**

In the first instance, this occurs when car carriers delivering to the Bellamys Citroën garage park on Holme Lacey Road North side, adjacent to the Citroën dealership as shown in figures 2.1(a) and (b).

During the delivery activities both car carriers obstructed the traffic flow due to private cars being parked on double yellow lines, next to the entrance of the residential flats' car park, on Holme Lacey Road south side. This had a bottleneck effect on the traffic flow to / from Burnt Ash Hill causing temporary congestion.

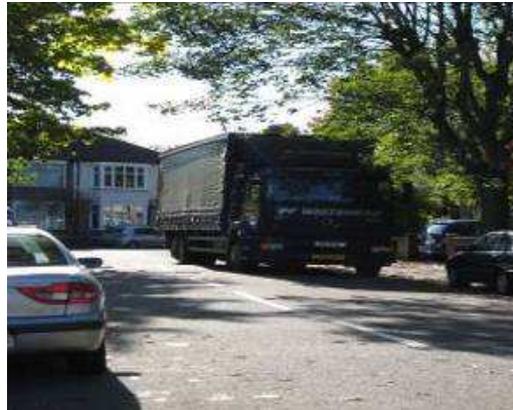
**Figure 2.2: PF Whitehead vehicle waiting on Dallinger Road to access the Travis Perkins yard**

to park on Dallinger Road for 30 minutes before accessing Travis Perkins yard to make its delivery.

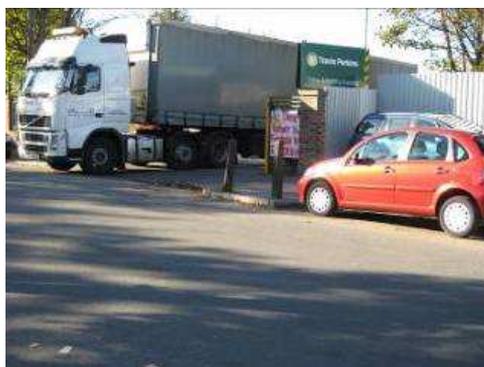
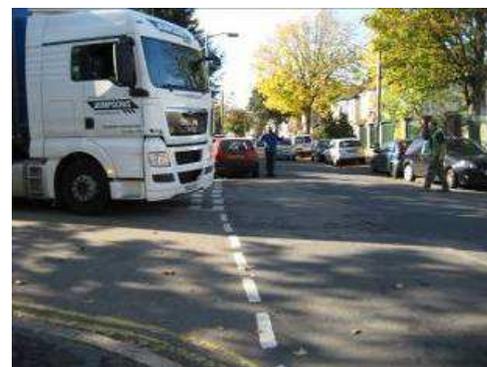
**Figures 2.3(a) and 2.3(b): Articulated lorry reversing manoeuvres at Travis Perkins yard**

In the case of articulated lorries, reversing manoeuvres into / out of the Travis Perkins yard obstruct the traffic flow (figures 2.3(a) and 2.3(b)). In order to facilitate a delivery inside the yard, the driver had to reverse out of the yard which impeded the traffic flow on Holme Lacey Road and Dallinger Road. This operation was assisted by a member of Travis Perkins' staff acting as banksman, who guided both the HGV driver and the other road users. This ensured that the manoeuvre was completed safely, in a location where the traffic was coming from all directions.

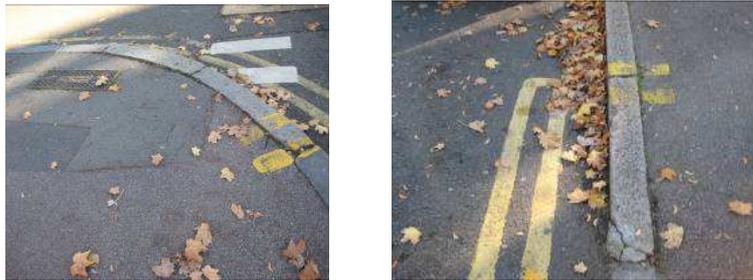
**Figures E.1 (a) and E.1 (b): Double yellow lines and pips at the corner of the junction**

The kerbside at the junction between Burnt Ash Hill and Holme Lacey Road is marked with double yellow lines and double pips, which are worn out as shown in figures E.1 (a) and E.1 (b). Generally, double yellow pips are used to indicate that loading is not allowed at any time for as far as the pips extend, and in this case they are provided around the corner of the junction.

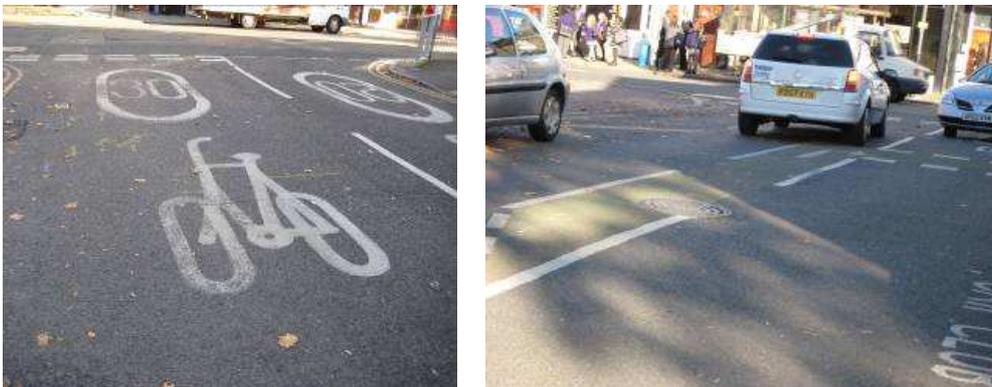
**Figures E.2 (a) and E.2 (b): Junction and cycle route markings on the carriageway**

As illustrated by Figures E.2 (a) and E.2 (b), the road markings indicated that vehicles have to stop when accessing Burnt Ash Hill on which a 30 miles per hour speed limit is imposed. However, the road markings at the junction despite being slightly worn are readable and conspicuous.

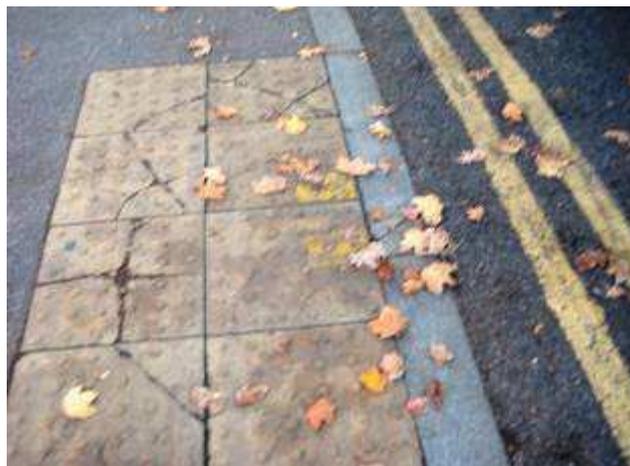
**Figure E.4: Tactile paving at the junction**

The pedestrian crossing has dropped kerbs and is provided with tactile paving for ease of use for people with disabilities. As shown in figure E.4, the paving at the informal pedestrian crossing shows signs of damage caused by vehicle activity, and these undulations might present a trip hazard for pedestrians with visual impairment and other powered wheel chairs which are more susceptible to changes in the smoothness of the surface type.

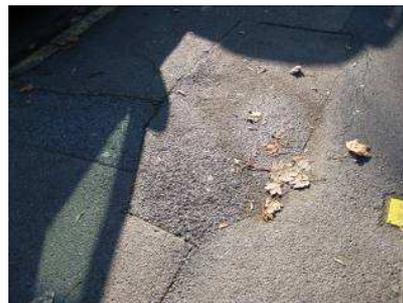
**Figure E.5: Irregular footway surface**

The footway surface adjacent to the junction is uneven and patched by previous works; these defects can be a trip hazard for pedestrians and footway users with mobility problems as shown in figure E.5.

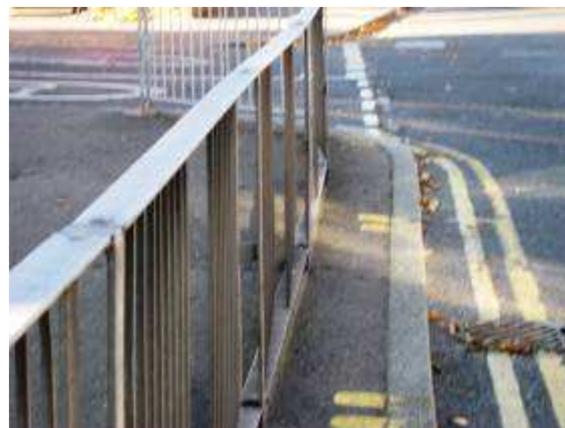
**Figure E.6: Double Yellow lines and pedestrian railings on South side of the junction**

On the South side of the junction pedestrians railings are provided to separate vehicle and pedestrian movements (figure E.6). The presence of these railings means that the kerbstones at the corner of this junction are in better condition than those present on the North side of the road.

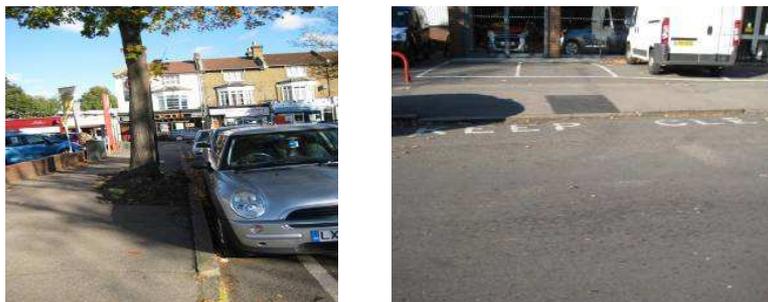
**Figure E.7(a) and E.7(b): Kerbside markings on Holme Lacey Road, North side**

On this side of the road, there is also the entrance to Citroën which is marked accordingly on the road. The Keep Clear sign which indicates the entrance to the Citroën premises is worn out and faded (figure E.7 (b)).

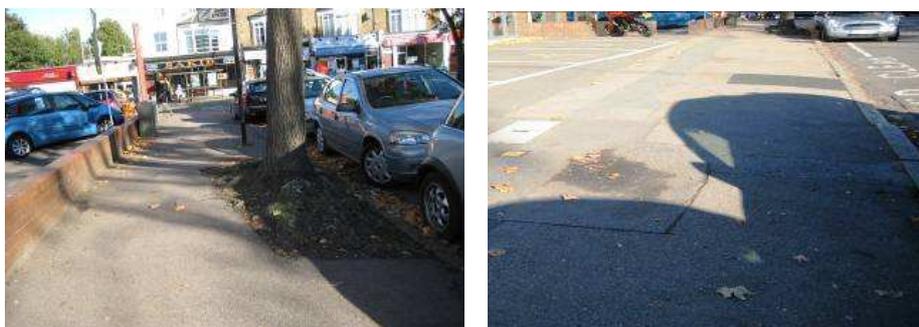
**Figure E.8(a) and E.8(b): Footway surface Holme Lacey Road, North side**

There is a footway for pedestrian traffic on the North side of Holme Lacey Road. The pavement surface presents extensive cracks, areas of patching and undulations in the surface around the trees. The trees restrict the footway surface available to the pedestrians and could potentially present a trip hazard for pedestrians and wheelchair users which are more likely to be affected by the sudden change and imperfections of the surface type as shown in figures E.8(a) and E.8(b).

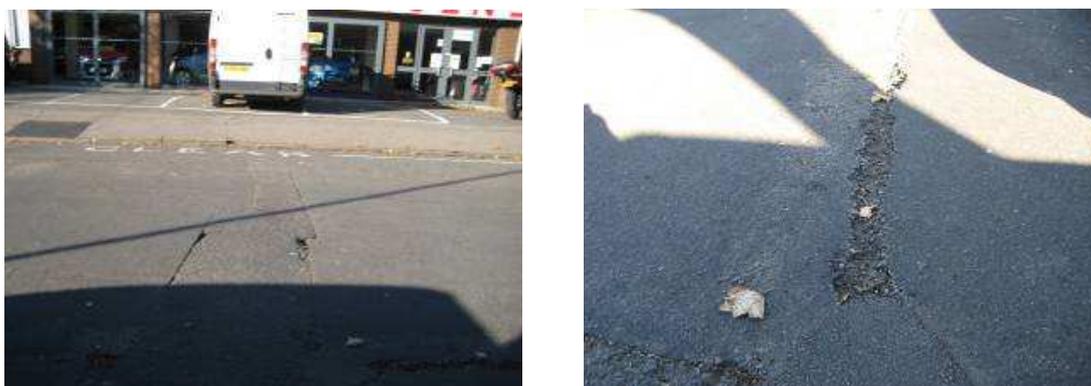
**Figure E.9(a) and E.9(b): Carriageway surface on Holme Lacey Road**

The carriageway surface on Holme Lacey Road has been patched, has some potholes and is uneven on large areas as shown in figures E.9(a) and E.9(b).

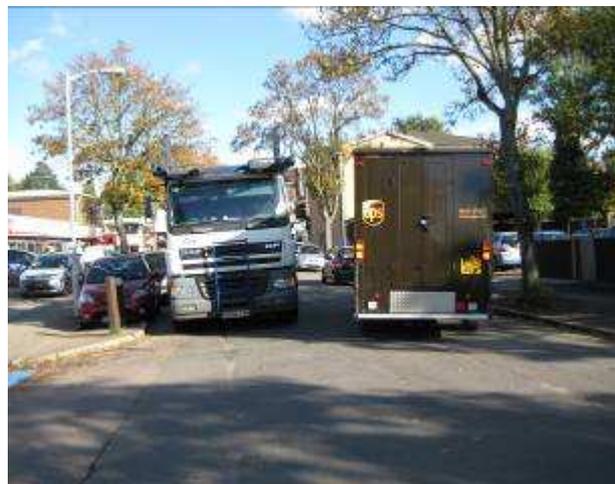
**Figure E.11: Unloading activity at Citroën, Holme Lacey Road, North side**

When deliveries take place at the Citroën garage, a whole traffic lane on Holme Lacey Road is blocked by the car carrier. The unloading activity carried out at Citroën can temporarily obstruct the traffic flow, restrict the size of the vehicles able to pass and can cause local congestion as shown in figure E.11.

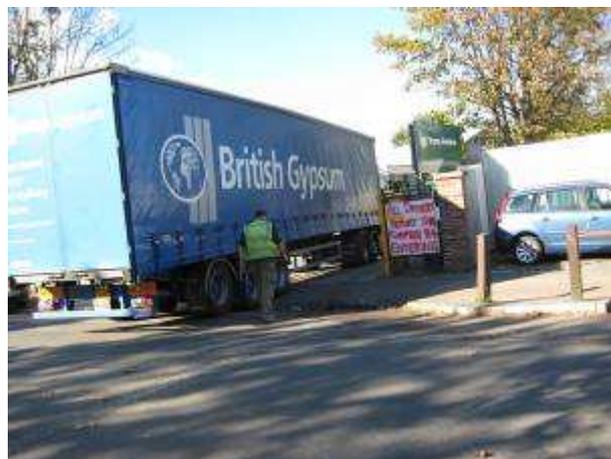
**Figure E.13: Articulated vehicle accessing Travis Perkins service yard**

The service yard is adequate for the majority of freight vehicles likely to use it including articulated goods vehicles, though these require manoeuvring in and out of the yard to enable them to be unloaded (figure E.13). It was noted that when the yard is full, articulated vehicles have to wait and park up on Dallinger Road and Holme Lacey Road until they are able to access the yard.

There is not always sufficient manoeuvring space for articulated vehicles to carry out deliveries and reverse in the yard. Sometimes the articulated vehicles get into the yard by reversing, or exit the yard by reversing into the road, thus affecting the traffic flow on Holme Lacey Road and Dallinger Road. When this occurs, multiple forward and reversing movements are required, often accompanied by the audible and visual reversing signals, increasing the noise pollution in the nearby residential area. These vehicle manoeuvres lead to temporary delays and congestion on the adjacent roads.

The carriageway surface around the yard entrance is cracked, with potholes and damages caused by heavy freight activity.

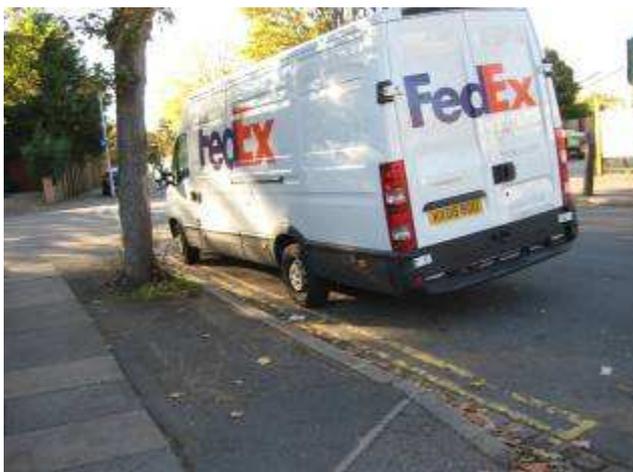
**Figure E.16: Parking on double yellow lines**

This side of the road is provided with double yellow lines, which are worn out. Despite this provision, non-compliant parking by vehicles awaiting entry or serving both Travis Perkins and the Citroën garage has been observed (figure E.16).

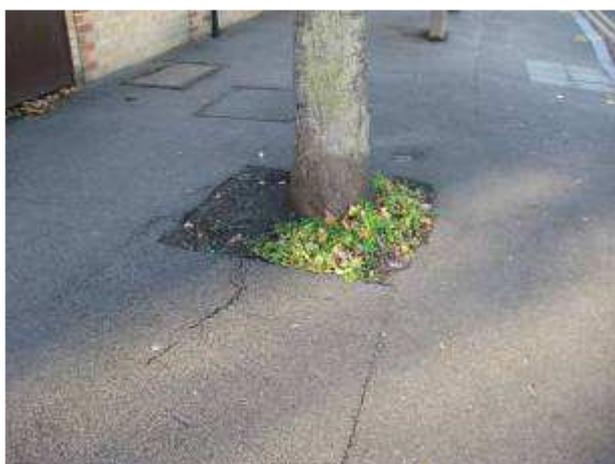
**Figure E.17: Footway surface**

The footway surface (figure E.17) on this side of the Holme Lacey Road is overall in better condition than on the other side of the road. The footway surface is a combination of paving slabs and tarmac with visible minor cracks.
