New Malden Commercial Vehicle Movement Study

Draft Final Report

**Royal Borough of
Kingston upon
Thames**

October 2008

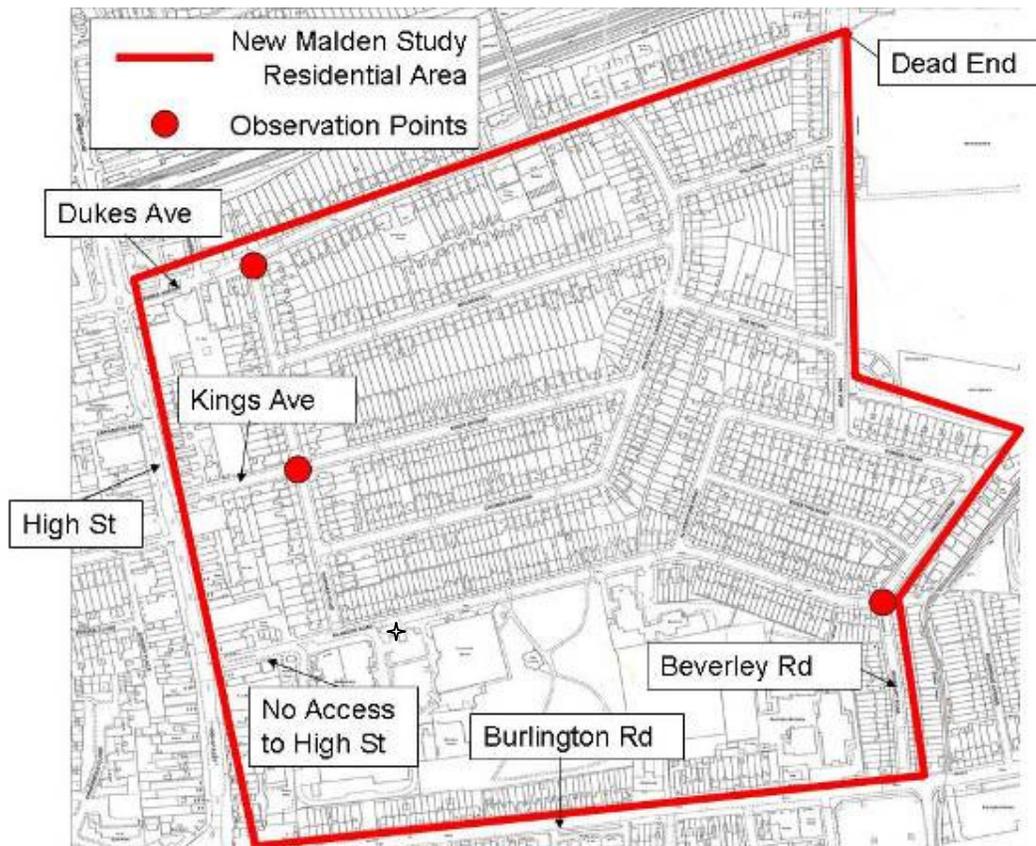
Figure 1 New Malden Study Residential Area & Observation Points

Figure 1 contains a map that shows the residential area between New Malden High Street and Burlington road. The residential area can only be accessed from the following 3 junctions:

1. Beverley Road with Burlington Road;
2. Dukes Avenue with Howard Road; and
3. Kings Avenue with Howard Road.

These 3 key locations were used in the study as observation points to monitor all commercial vehicles that accessed and egressed the residential area and are shown in Figures 2-4. Figure 5 shows the dead end located at the end of park view shown in Figure 1.

The observational survey was completed on Tuesday 30th September 2008. Two fieldwork staff were located at each of the 3 observation points (see figure 1) that cover all access and egress locations to the residential area from the High Street and Burlington Road.

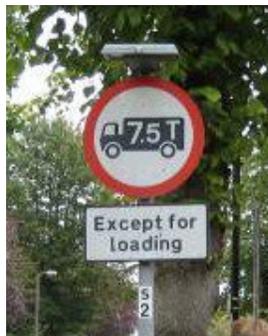
Figure 6 Weight Restriction Signage

The study residential area has a prohibition on goods vehicles exceeding 7.5 tonnes maximum permissible weight except for loading and this is signed at each of the 3 access points (see Figure 6). A notice is also located on the entrance to Blagdon Road (located off of Beverley Road) stating that this is not a through route to the High Street (see Figure 7).

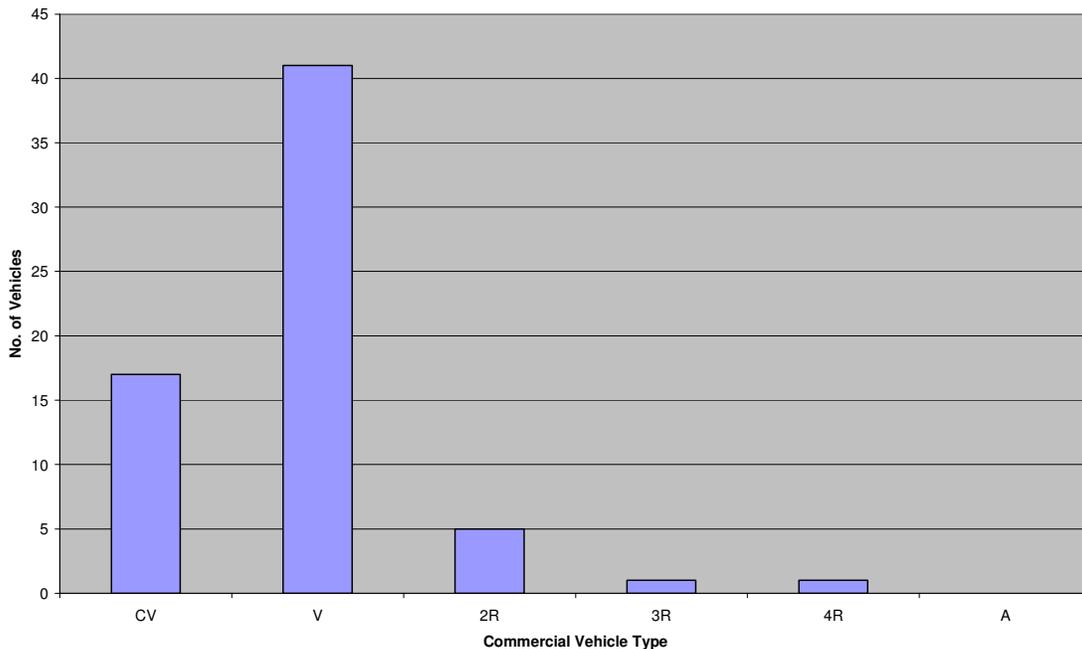
Figure 8 Commercial Vehicles Observed between 0730 and 0900

A total of 65 commercial vehicles were observed during this observation period in the New Malden residential area. Figure 8 shows that the majority of commercial vehicles were either vans (V) or car-derived vans (CV), with only five 2-axle rigid, one 3-axle rigid and one 4-axle rigid goods vehicles observed in the area.

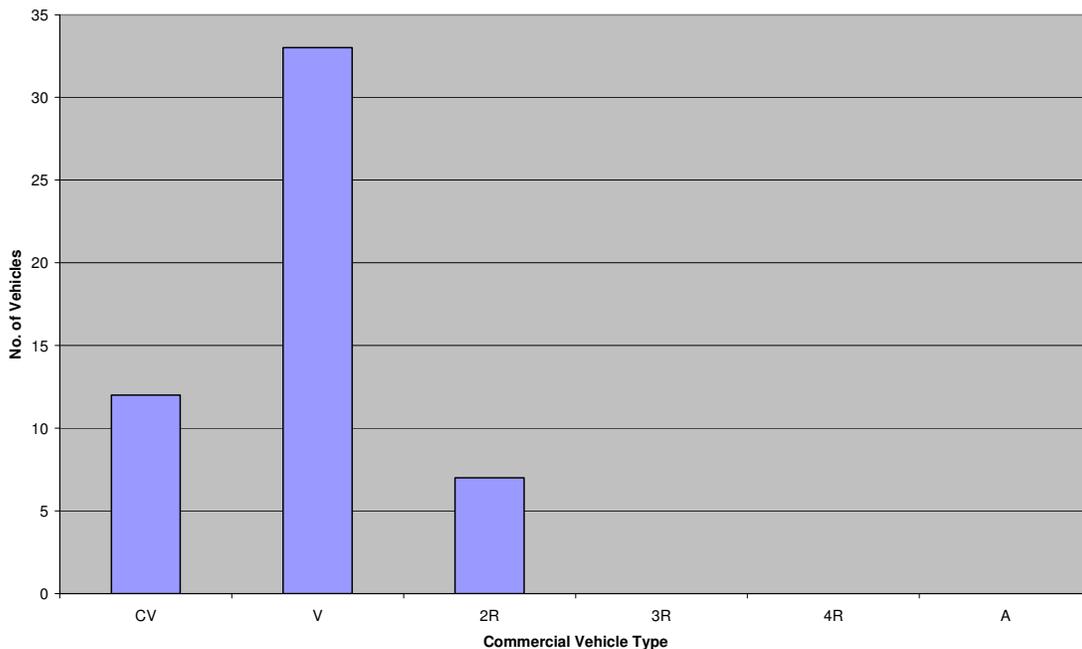
Figure 9 Commercial Vehicles observed between 1100 and 1200

A total of 52 commercial vehicles were observed during this observation period in the New Malden residential area. Figure 9 shows that the majority of commercial vehicles were either vans (V) or car-derived vans (CV), with only seven 2-axle rigid goods vehicles observed in the area.

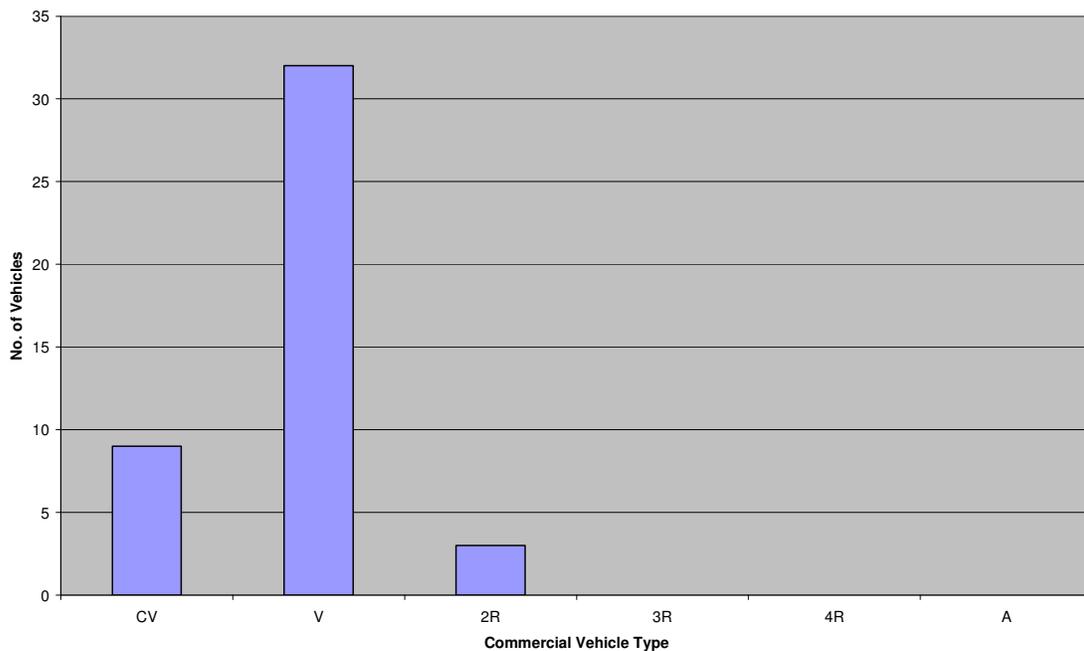
Figure 10 Commercial Vehicles observed between 1430 and 1530

A total of 44 commercial vehicles were observed during this observation period in the New Malden residential area. Figure 10 shows that the majority of commercial vehicles were either vans (V) or car-derived vans (CV), with only three 2-axle rigid goods vehicles observed in the area.

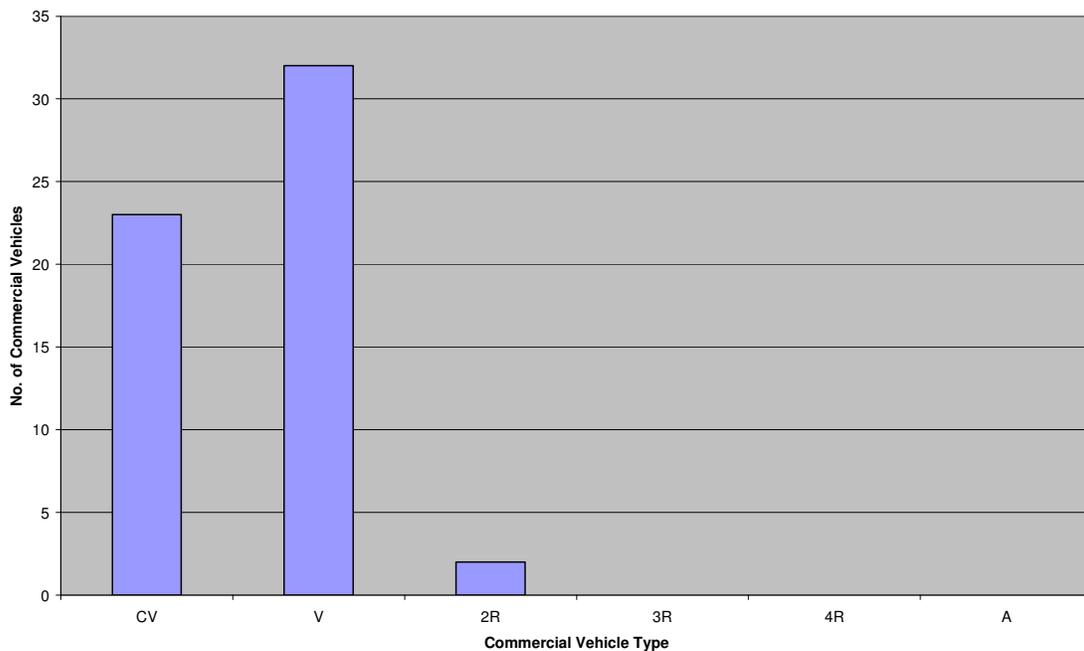
Figure 11 Commercial Vehicles observed between 1630 and 1800

A total of 57 commercial vehicles were observed during this observation period in the New Malden residential area. Figure 11 shows that the majority of commercial vehicles were either vans (V) or car-derived vans (CV), with only two 2-axle rigid goods vehicles observed in the area.

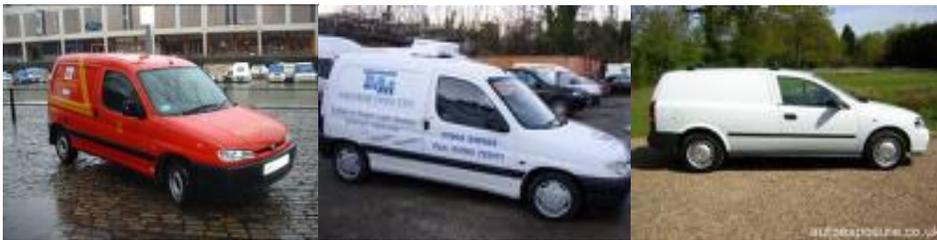
CV - CAR-DERIVED VAN

- CV – Car-Derived Van;
- V – Van (up to 3.5 tonnes maximum permissible weight);
- 2R – Two-Axle Rigid Goods Vehicle (over 3.5 TES MPW);
- 3R – Three-Axle Rigid Goods Vehicle;
- 4R – Four-Axle Rigid Goods Vehicle; and
- A – Articulated Vehicle.

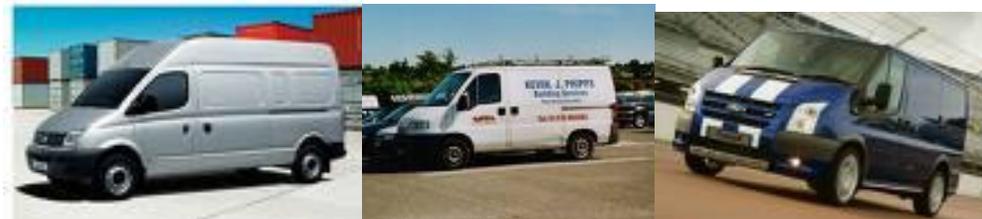
V - VAN (UP TO 3.5 TONNES MAXIMUM PERMISSIBLE WEIGHT)

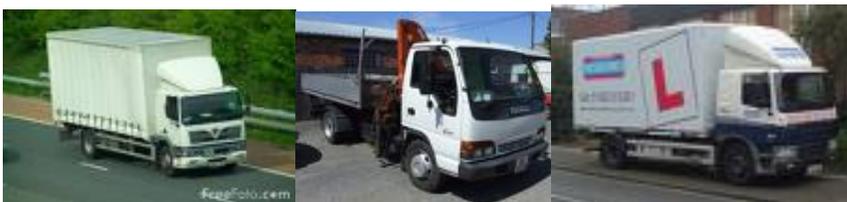
2R - TWO-AXLE RIGID GOODS VEHICLE (OVER 3.5 TONS MPW)

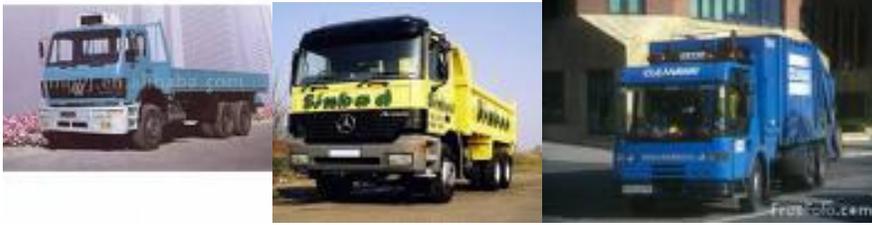
3R - THREE-AXLE RIGID GOODS VEHICLE

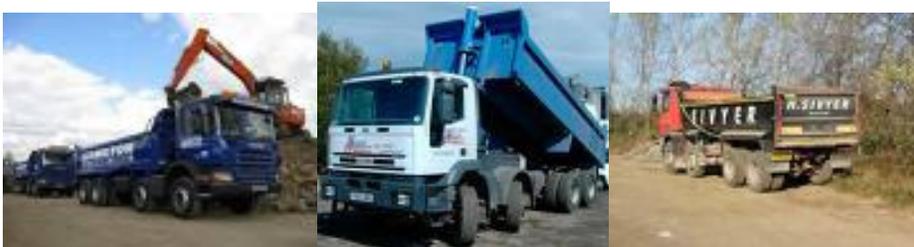
4R - FOUR-AXLE RIGID GOODS VEHICLE

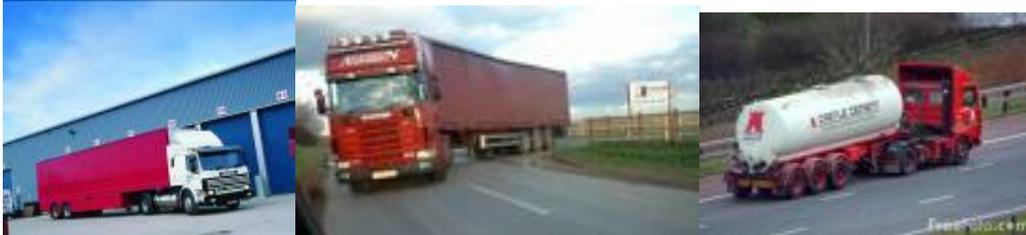
A - ARTICULATED VEHICLE
