# St Johns Road, Clapham Delivery and Servicing Observation Study

**London Borough of  
Wandsworth**

**South London Freight  
Quality Partnership**

**Draft Report**

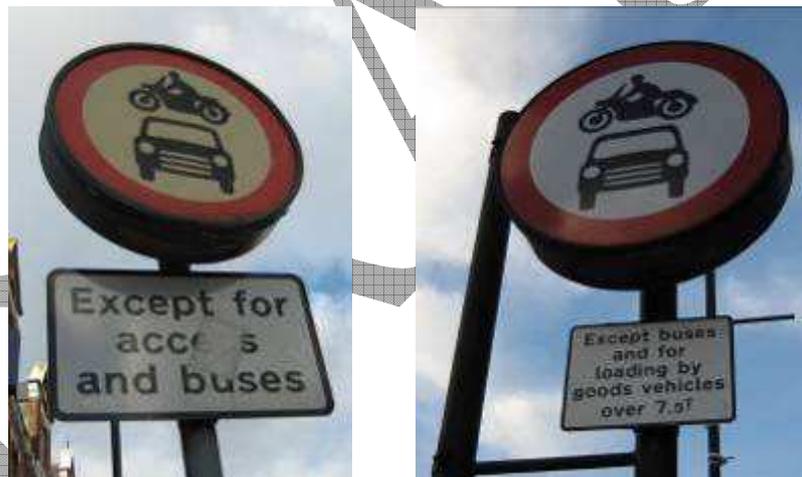
**Figure 3.2:** St Johns Road Vehicular Access Signage [on St Johns Road itself (left)] and at the junction with the A3 [right]

However, signage on St Johns Road itself, and at the A306/A3207 and A3/Northcote Road junctions is inconsistent, with 3 different pieces of signage indicating different access restrictions (see Figure 3.2:). The image on the left shows that cars and motorcycles are prohibited, and the right-hand image, located at the junctions to enter St Johns Road from the A3/Northcote Road, and the A306/A3207, indicate access only to buses and commercial goods vehicles of 7.5T gross vehicle weight or more for the specific purpose of loading.

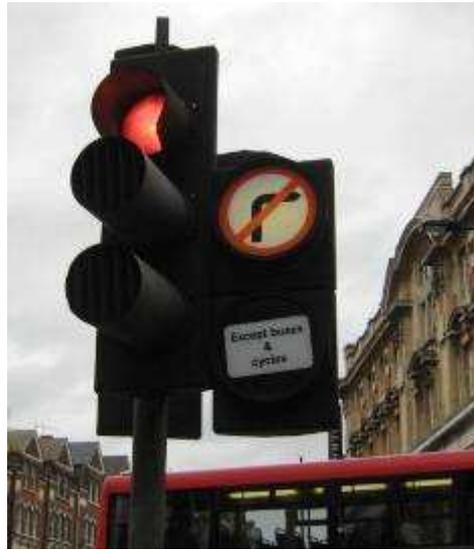
**Figure 3.3:** St Johns Road Vehicular Access Signage mounted on traffic lights at the junction of the A306/A3207

There is also conflicting signage mounted on the traffic lights at the junctions to enter St Johns Road from the A3/Northcote Road and A306/A3207, which prohibit turns into St Johns Road except for bicycles and buses (Figure 3.3:).

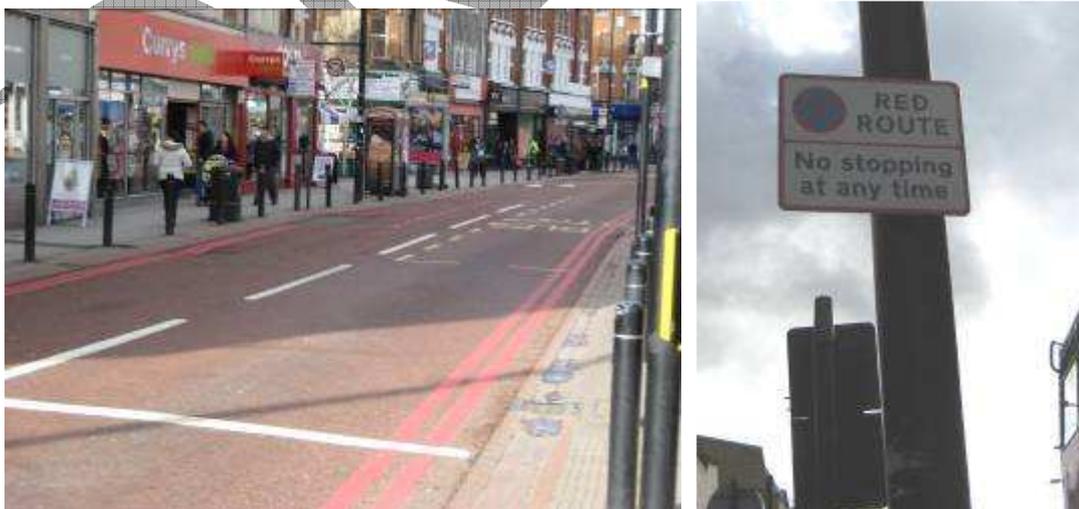
**Figure 3.4:** Red Route Signage and Road Markings

Whilst St Johns Road is a Borough controlled route, the stretch of St Johns Road from the junction with Aliwall Road (in as southerly direction) to the junction with the A3/Northcote Road is designated as a Red Route (Figure 3.1:). The Red Route affects both carriageways, with no stopping allowed on the northbound carriage at any time Monday to Saturday 07:00 – 19:00 (outside of the Loading Bay). On the southbound carriageway, signage is also present indicating no stopping at any time on the approach to the junction with the A3/Northcote Road.

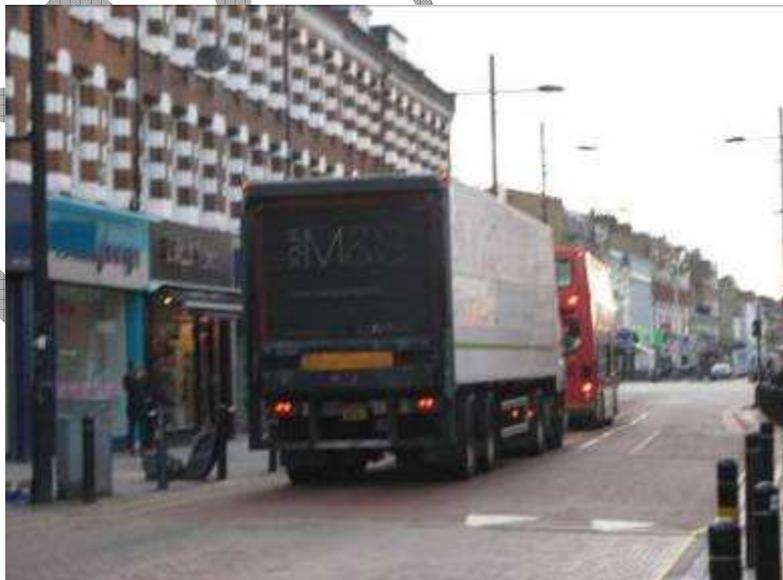
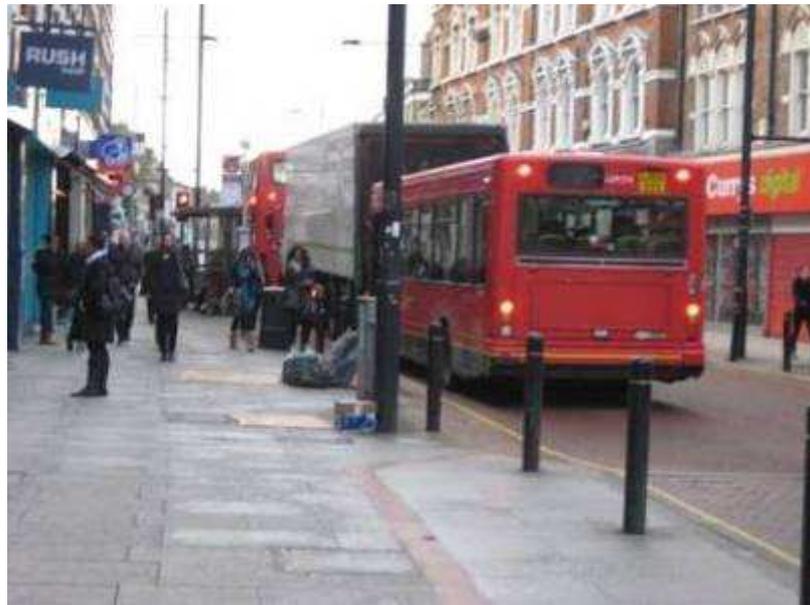
**Figure 4.2: Marks and Spencer vehicle exiting St Johns Road**

In one instance, a Marks and Spencer commercial vehicle which had carried out its delivery activity, and was seeking to exit St Johns Road, was waiting at the traffic light controlled junction of the A3/Northcote Road. This vehicle, which was, behind a waiting bus, prevented buses from accessing the bus stop on the southbound carriageway of St Johns Road (leading to junction with the A3/Battersea Rise). This led to mums with school children having to walk along the pavement, away from the sheltered bus stop to where the bus was able to stop. As such the commercial vehicle was caught between two buses, as shown in .

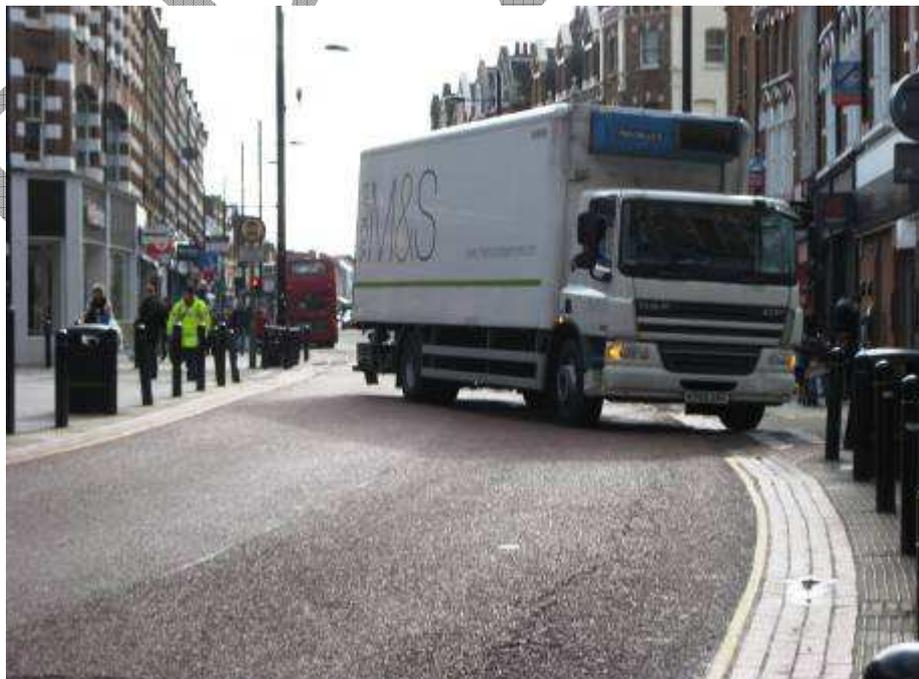
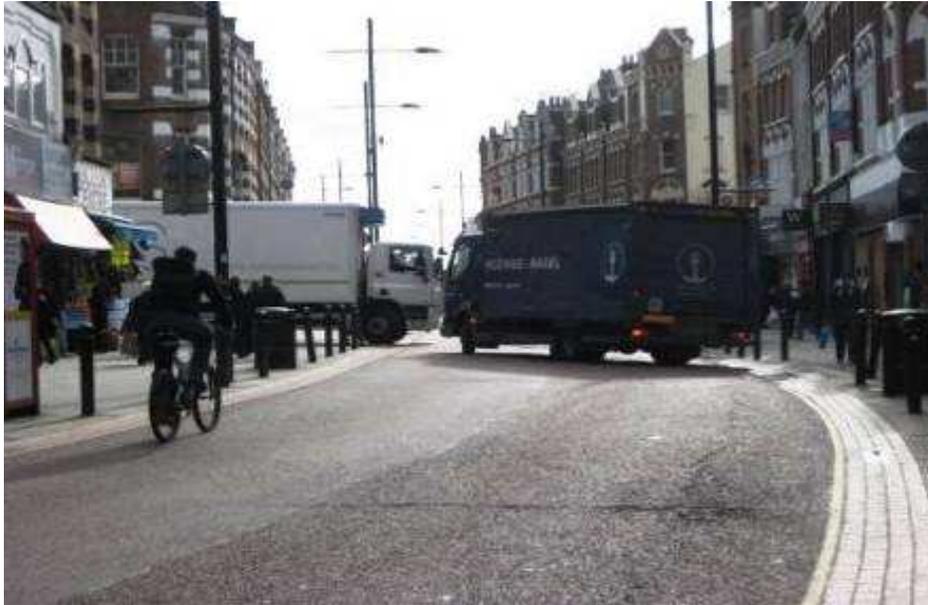
**Figure 4.4: Marks and Spencer Articulated Goods Vehicle reversing into and exiting from Barnard Road**

During the morning observations, two Marks and Spencer articulated goods vehicles accessed St Johns Road, before reversing into the Marks and Spencer delivery yard located on Barnard Road. The first goods vehicle was already in the delivery yard when the surveying period started at 06:30 and had departed by 08:08 via Battersea Rise.

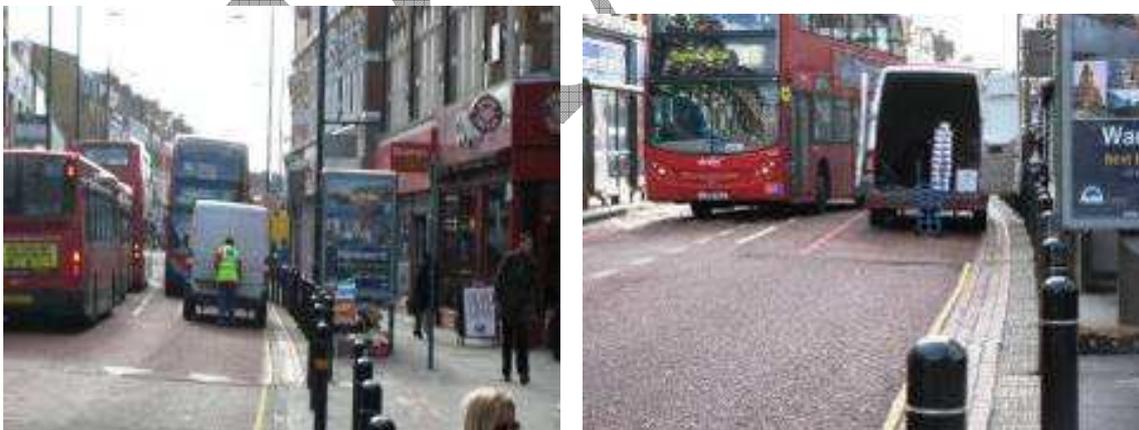
**Figure 4.6: Vans using the Red Route loading bay**

It was observed that congestion on the southern end of St Johns Road is caused by commercial vehicles using the existing loading bay on the northbound carriageway of St Johns Road. This can lead to buses, which come from Battersea Rise, having difficulties in entering St Johns Road when the following combination of factors occurs:

- When commercial vehicles use the existing loading bay on the northbound carriageway at the same time as buses stop in the bus stop on St Johns Road southbound carriageway, just before the junction with Battersea Rise.

Congestion at the southern end of St Johns Road is also caused by the traffic controlled junction of St Johns Road and Battersea Rise, which can lead to buses waiting/queuing at the traffic lights. The congestion is relieved when buses depart the bus stop, exit St Johns Road, or when the loading bay becomes vacant.

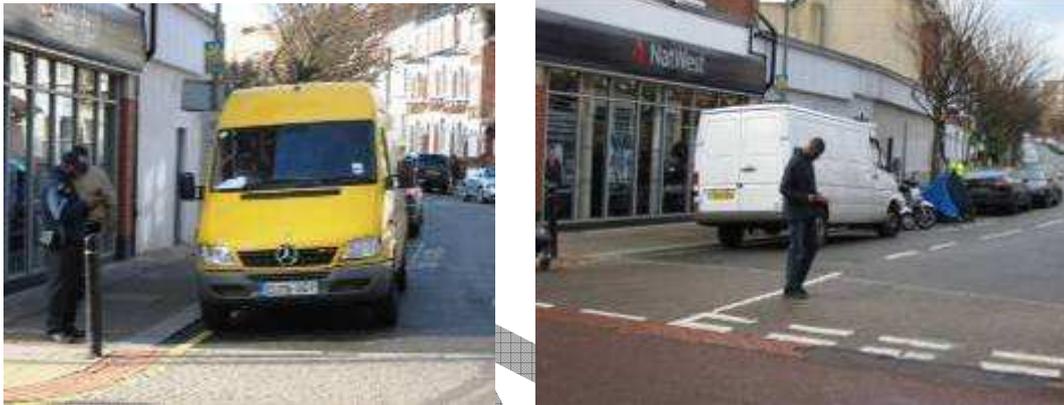
**Figure 4.7: Van parked on Comyn Road**

It was observed that commercial vehicles stopping north of the loading bay and closer to Costa coffee shop have a lesser effect on the buses' flow on St Johns southbound. There is also no or limited impact on traffic flow along St Johns Road of commercial vehicles stopping for loading and unloading on the adjacent side roads such as Bernard Road or on Comyn Road (by Nat West).

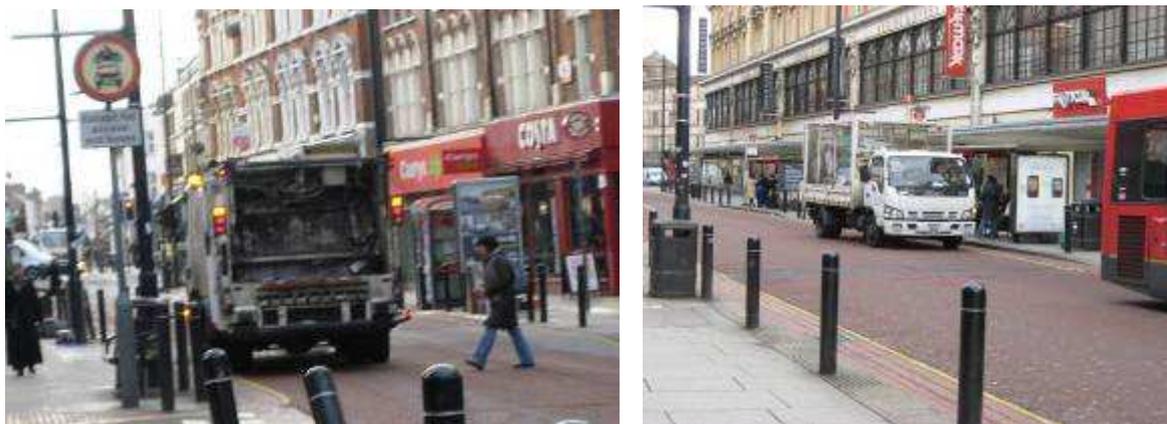
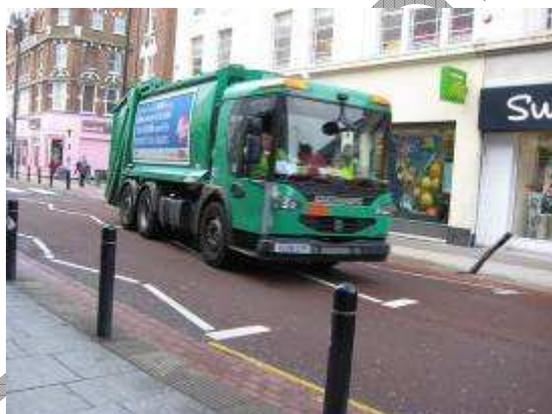
**Figure 4.8: Waste vehicle observations**

At least three separate waste collection service providers were observed servicing various businesses on St Johns Road. The collections observed occurred throughout the morning (at 06:54, 09:48 and 11:40). All of the waste collection vehicles stopped at various points along St Johns Road.

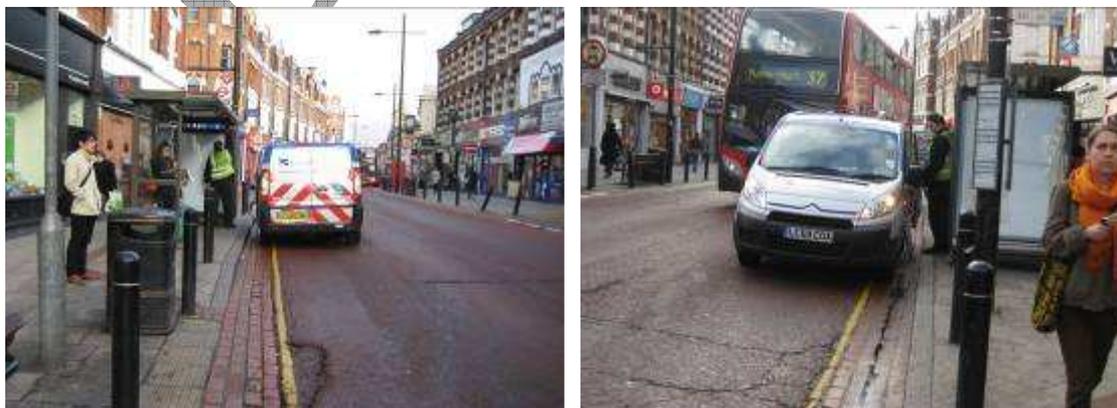
**Figure 4.10: Van servicing the bus stop**

Buses were prevented from pulling onto the northbound bus stops when a Clear Channel maintenance van stopped along St Johns Road to change the advertisements in all the bus stops on the northbound of St Johns Road.

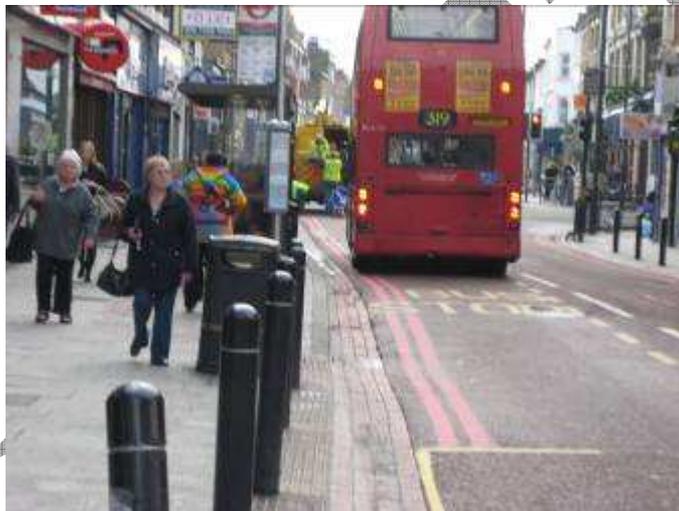
**Figure 4.11: Team removing the Christmas lights**

At 9:56 a van was observed removing the Christmas lights on St Johns Road (Figure 4.11:). Whilst this activity was carried out the van caused temporarily congestion at both ends of St Johns Road, (the junctions with Battersea Rise and with Lavender Hill). The servicing van took over 30 minutes to complete its activities and had multiple stops along St Johns Road.

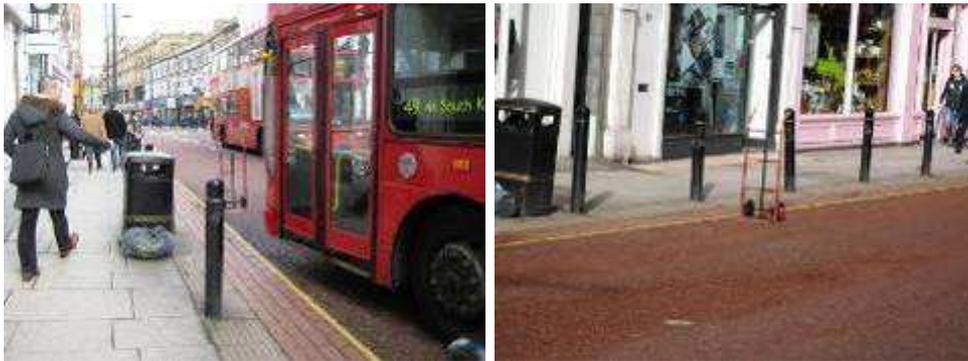
**Figure 4.12: Delivery trolley left in the middle of the road**

During the morning observations, one potentially dangerous occurrence was observed whereby a manual handling trolley used for deliveries was left in the middle of the road by a commercial vehicle driver after the delivery was completed. This had a brief impact on bus flow along St Johns Road.

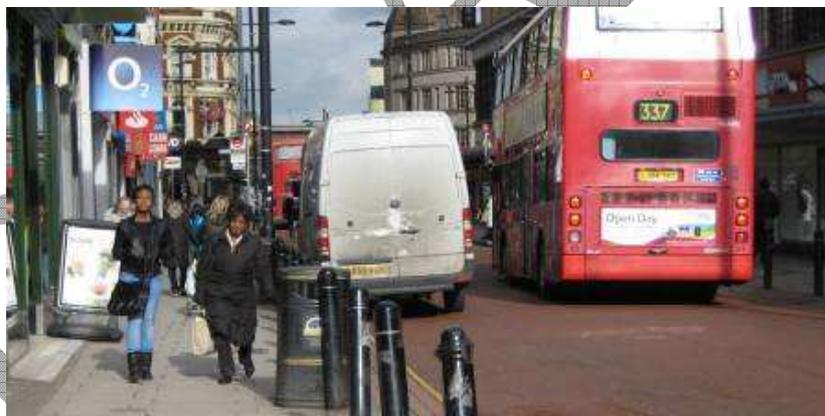
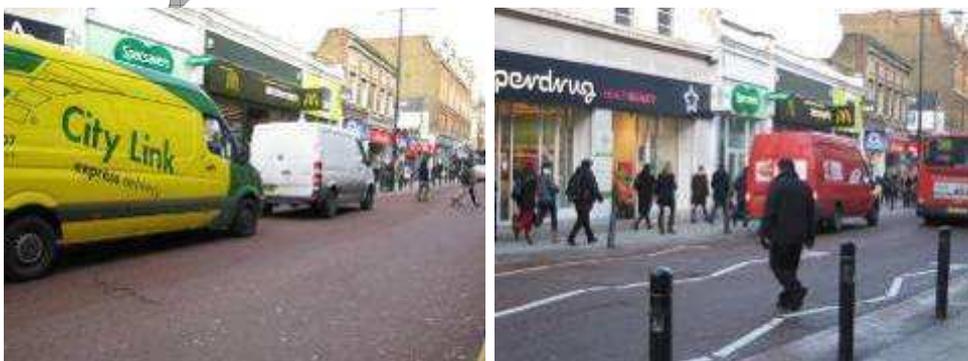
**Figure 4.13: Vans stopping at McDonalds, Superdrug part of St Johns Road**

Commercial vehicles were frequently observed parking on the northbound carriageway of St Johns Road, by McDonalds and Superdrug. This location is used for deliveries to businesses located on St Johns Road, but also to Lavender/St Johns Hills. Commercial vehicle drivers were also observed having their breakfast/lunch during their work break.

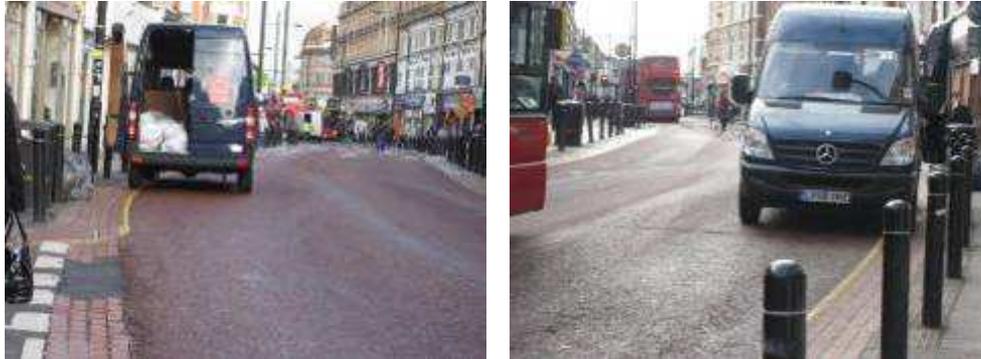
**Figure 4.15: Location by BHF**

Another location frequently used by commercial vehicles for deliveries is located on the south west of St Johns Road by the British Heart Foundation outlet and Brook Street.

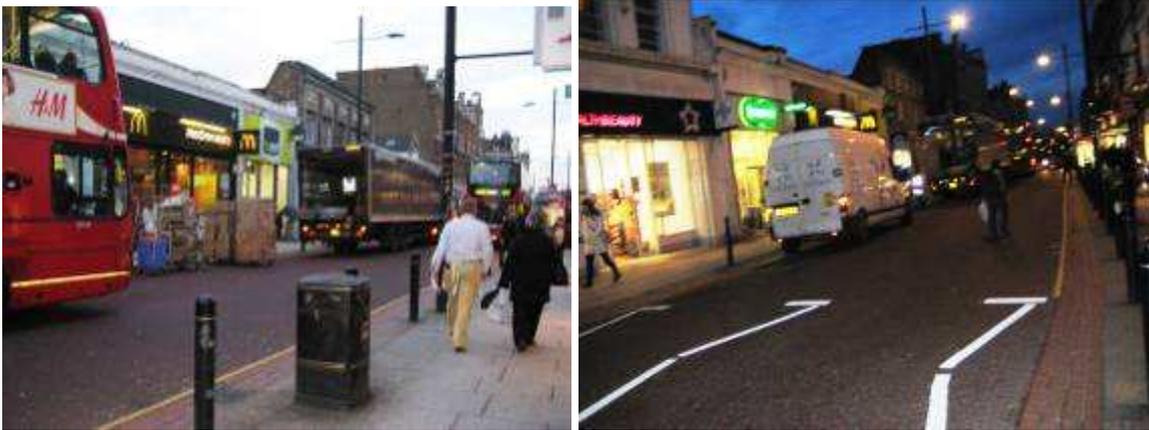
**Figure 4.16: McDonalds delivery impact on Bus flow and Vehicle Bunching**

- A delivery to McDonalds which lasted for approximately 1 hour from around 17:00 until 18:00. This delivery was made by a 4 axle vehicle of gross vehicle weight of approximately 18T. The vehicle stopped on the North bound carriageway south of bus stops, but relatively close to bus stops on the southbound carriageway.

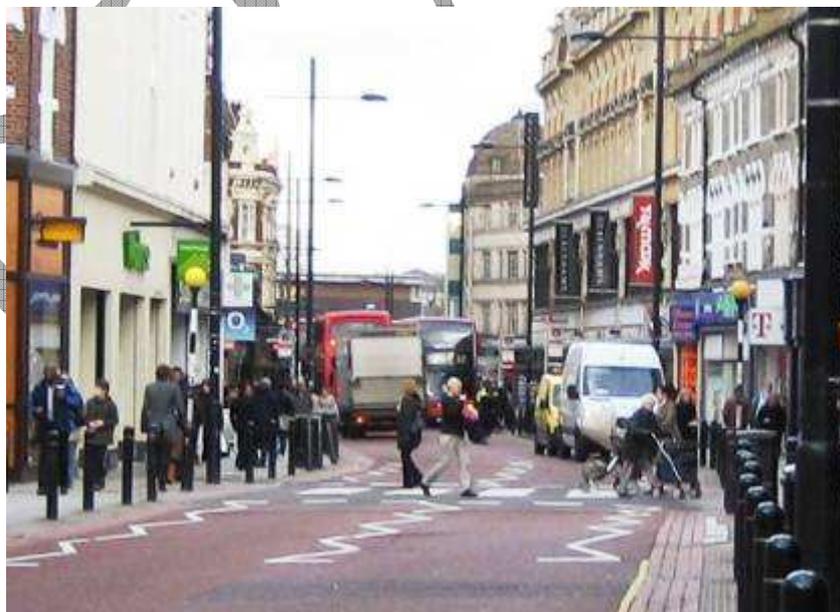
**Figure 4.17: Foot Locker (left side of the photo) delivery impact on bus flow**

- In addition to the McDonalds delivery, 2 other delivery vehicles (belonging to Royal Mail and Unichem) stopped to the south of the vehicle to make deliveries/collections to Superdrug and Santander at the same time as the McDonalds delivery was occurring. However, these other deliveries were of shorter duration, with the Royal Mail vehicle having no impact on bus flow.
- During the early afternoon, Foot Locker received a delivery from a 2 axle rigid goods vehicle (UPS), delivering from the northbound carriageway outside of the store. This negatively impacted significantly on bus flow at the northern end of St Johns Road, with the delivery taking 21 minutes to complete.

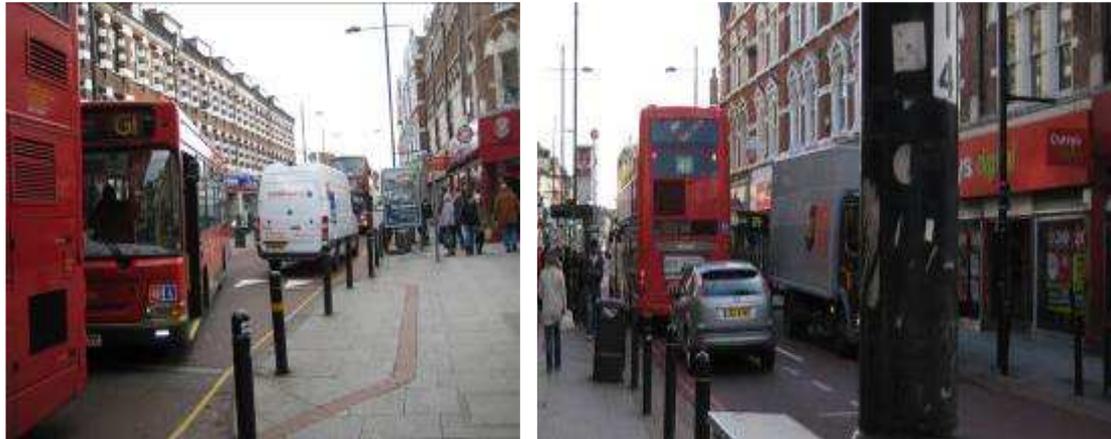
**Figure 4.18:** Delivery impact on North bound carriageway on bus flow at the Southern end of St Johns Road

- Similarly to the morning observations, commercial vehicles, notably vans (but also including 2 axle goods vehicles) carrying out delivery activity at the southern end of St Johns Road also impacted on bus flow, whether they were using the Red Route loading bay or not. This included deliveries made through the afternoon and early evening by UPS, TNT, Interlink Express,

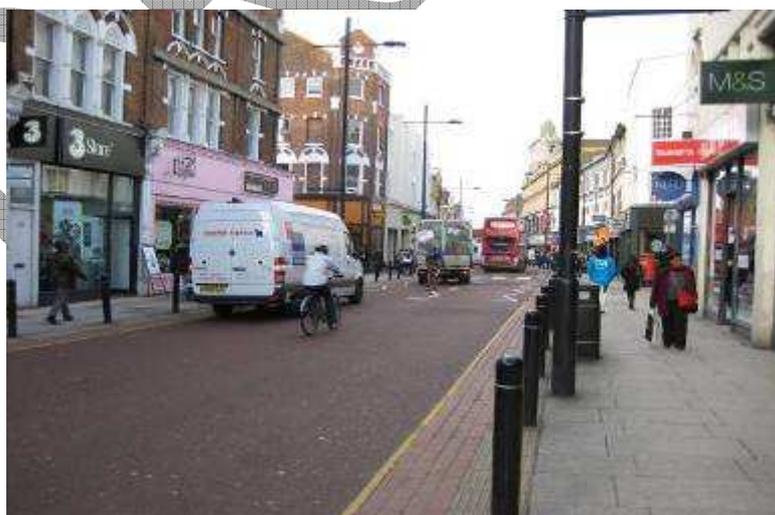
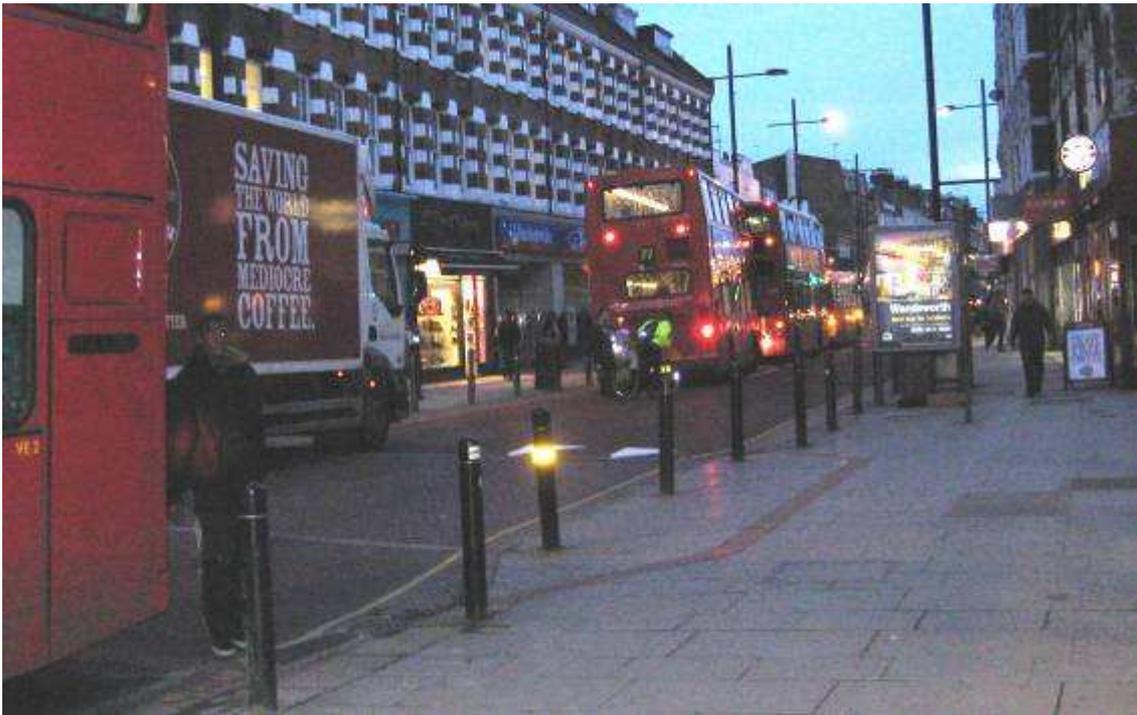
**Figure 4.19:** Cyclists manoeuvring along St Johns Road with other road users

Of the 28 instances of delivery and servicing activity observed in the afternoon, 3 of these required cyclists to make significant manoeuvres around delivery vehicles, with approximately 12 instances of cyclists having to make minor adjustments to continue along St Johns Road. With regards those instances requiring significant manoeuvres, in some of these cases cyclists were stuck in the middle of the road between a commercial vehicle on one side and a bus on the other. This is not a safe environment for cyclists.

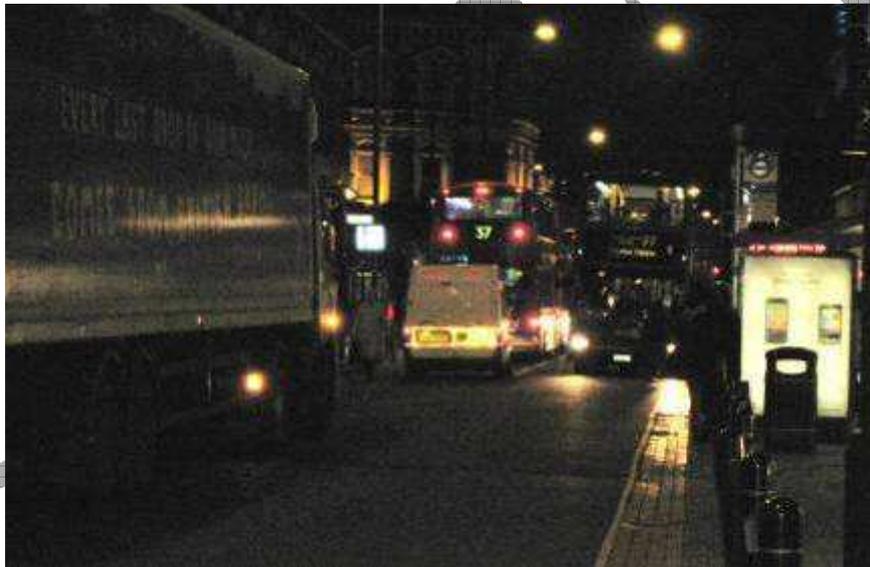
Figure 4.21: Emergency Service Vehicle Unable to Exit St Johns Road

However, at 17:50, a police van trying to exit via St Johns Road northbound was not able to exit promptly onto the A306 due to the presence of buses blocking both carriageways – stopped at the bus stops on the southbound carriageway and waiting for traffic lights on the northbound carriageway.

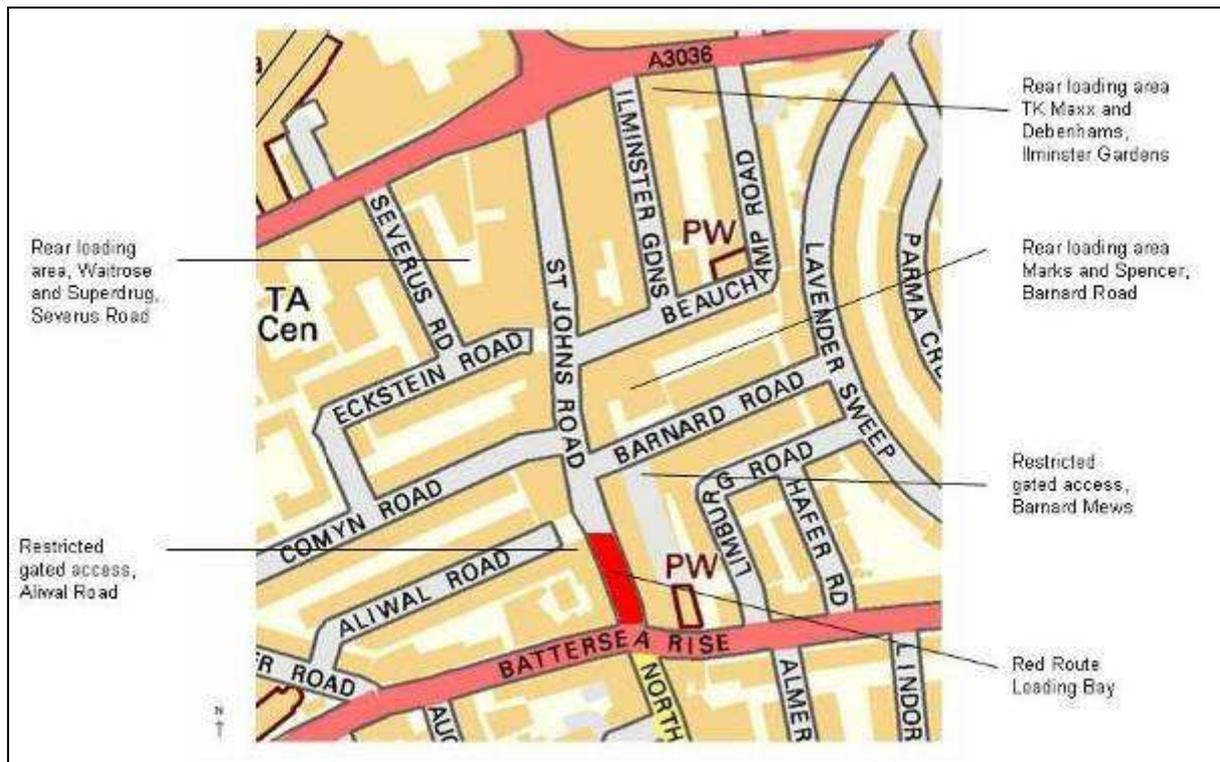
**Figure 5.1: Provision of loading/unloading facilities and rear access in the St Johns Road area.**

Figure 5.1: shows the provision of loading/unloading facilities, and the provision of rear access in the St Johns Road area.

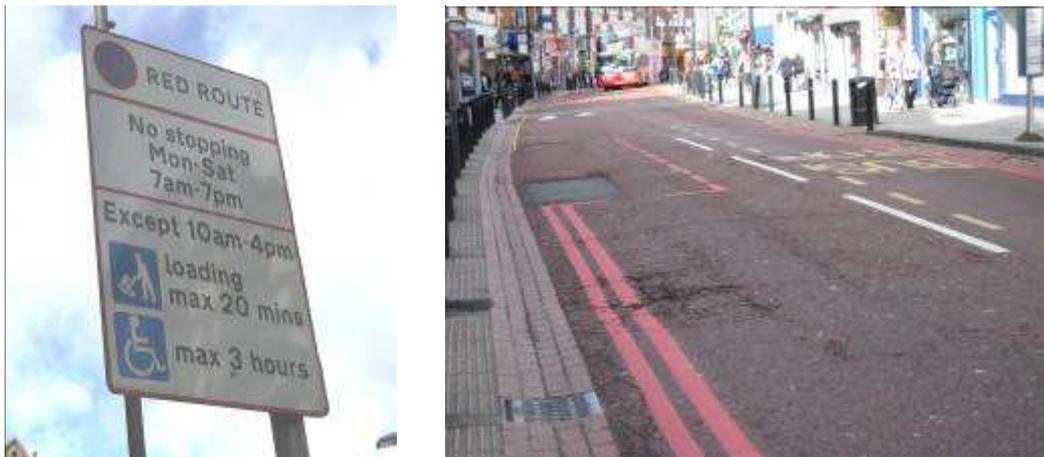
**Figure 5.2: Red Route Loading Bay Usage Signage and Road Layout**

The loading bay is a shared use (disabled) red route loading bay, allowing loading/unloading activities for 20 minutes between 10am and 4pm. Directly opposite the loading bay on the southbound carriageway is a bus stop which is extensively used throughout the day.

- Any use of the Red Route loading bay has a negative impact on traffic flow and presents difficulties for other road users. This is as a result of its location directly opposite the bus stop on the southbound carriageway which is in constant use throughout the day.

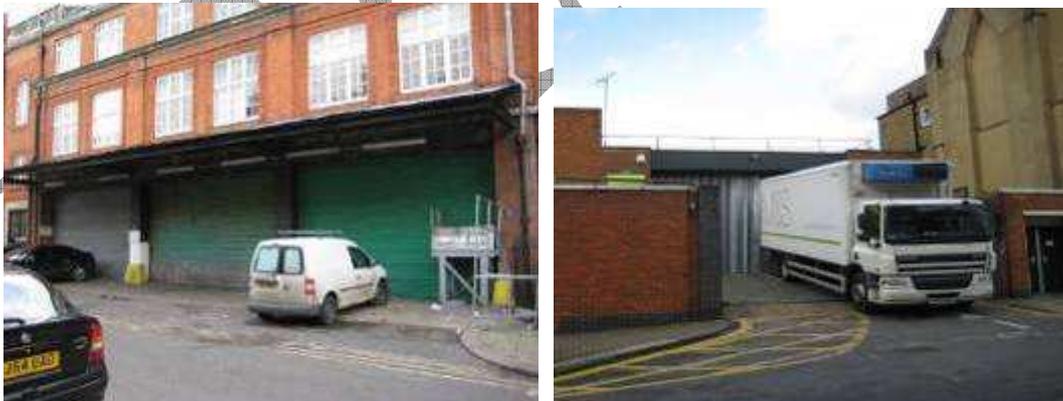
**Figure 5.3: TK Maxx and Debenhams Rear Access (left) and Marks and Spencers (right)**

There are exceptions – these include on Ilminster Gardens where there is a rear loading access area available for use by TK Maxx and Debenhams – and on Barnard Road, where Marks and Spencer has its own delivery yard with rear access.

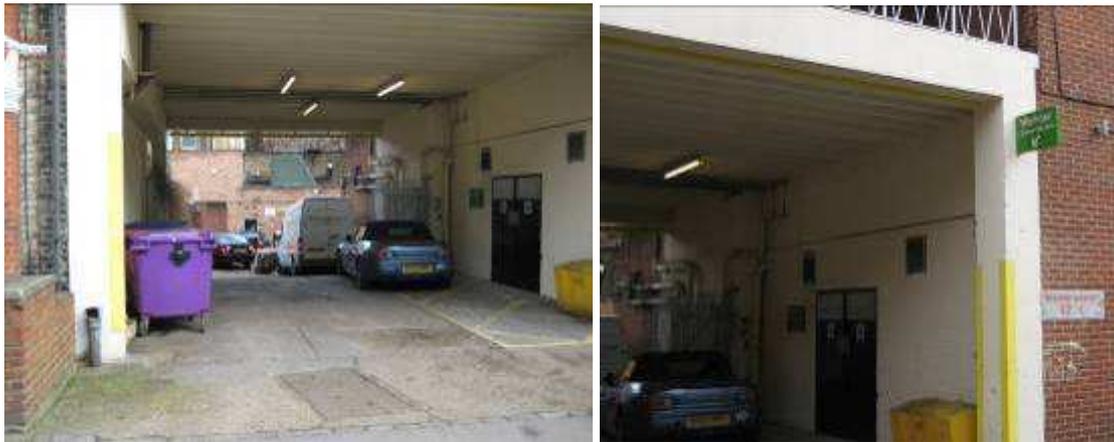
**Figure 5.4: Rear Access Area on Severus Road**

On Severus Road, there is a rear access area which is believed to be for use by Waitrose and Superdrug. However, the area is used as storage area for waste bins and for customer collections, as well as having restricted ceiling height of 12ft 6". As a result, it is likely that deliveries from larger vehicles are received via the customer entrance on St Johns Road.

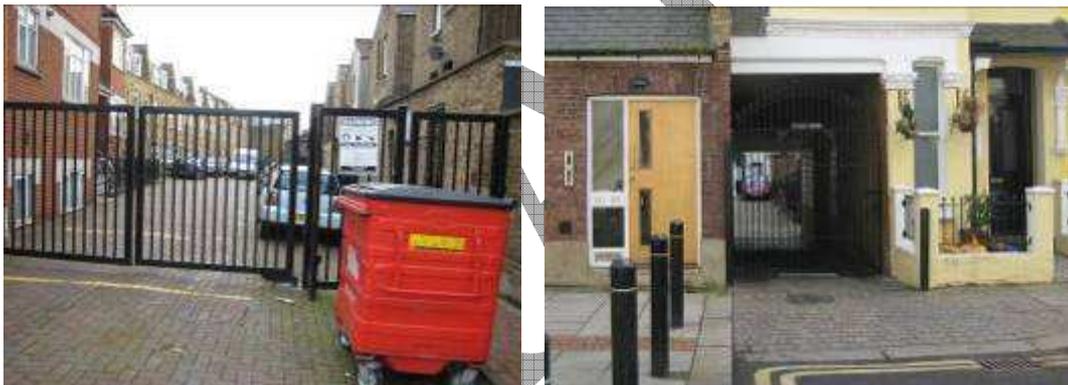
**Figure 5.5: Rear Access via Barnard Mews (left) and Aliwal Road (right)**

Rear access is also available to businesses via Aliwal Road, although this is to pedestrians only, with no vehicle access, and gated rear access is available via Barnard Mews.

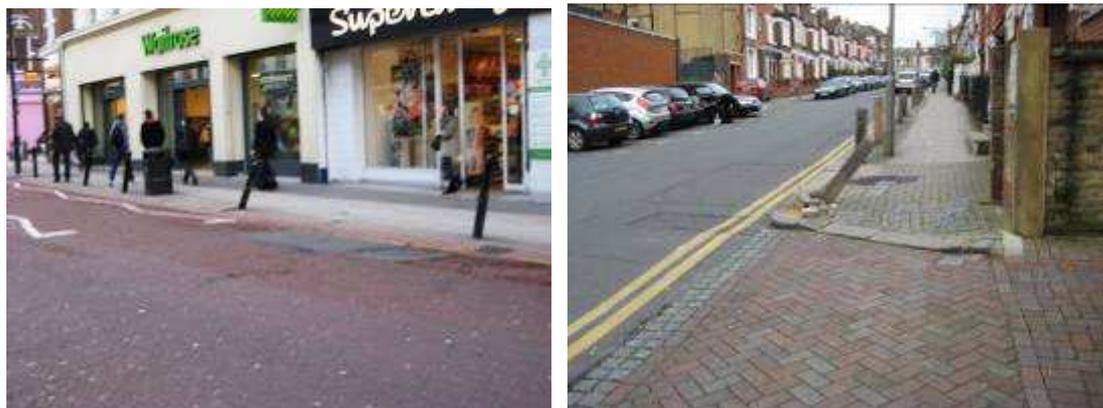
**Figure 5.6: Damaged bollards on St Johns Road (left) and Barnard Mews (right)**

On St Johns Road, there is clear evidence that vehicle strikes have been observed to bollards on the northbound carriageway in the area of Waitrose, Superdrug and McDonalds. This could be the result of strikes by commercial goods vehicles, waste collection vehicles or buses. It was also observed in the morning that commercial vehicles were reversing onto St Johns Road from side streets, which could also be the cause of the damage.

In addition to the strikes observed on St Johns Road, similar strikes have been observed at the entrance to Barnard Mews. .

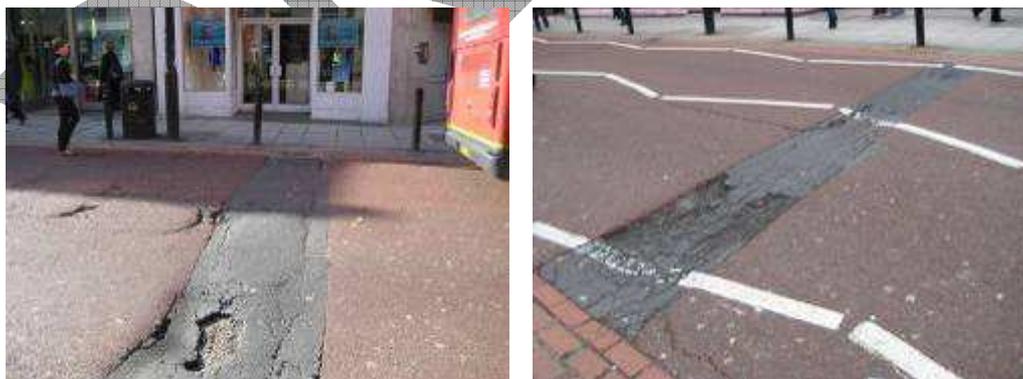
**Figure 5.7: Carriageway Damage by TK Maxx (left) and L'Occitane (right)**

It is recognised that there are stretches of St Johns Road which show significant signs of degradation and use by heavy vehicles such as buses and large goods vehicles. Areas of St Johns Road where this was observed include by TK Maxx, L'Occitane and south of the Red Route loading bay on the northbound carriageway.

This damage to the carriageway presents hazards to all road users.

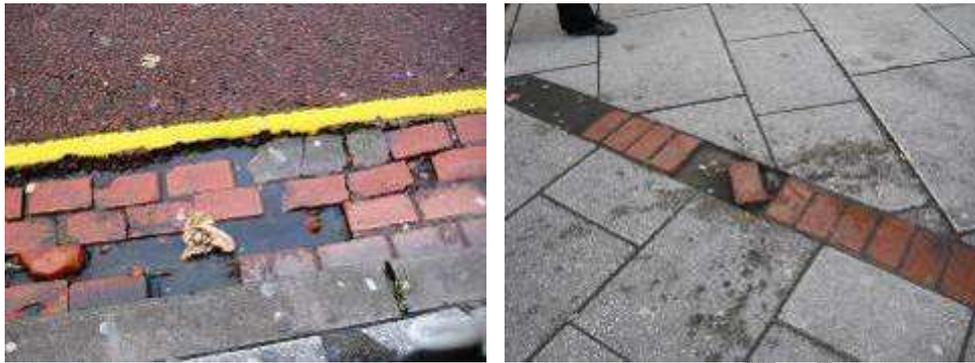
**Figure 5.8: Kerbstones' damage at TK Maxx and uneven pavements**

In the area close to the TK Maxx bus stops, kerbstones from the carriageway were missing, presenting a potential trip hazard for public transport users. The footway surface also has parts missing or bricks out of place that might be another trip hazard for pedestrians.
