Putney High Street Delivery and Servicing Study

Final Report

**South London Freight Quality
Partnership**

February 2011

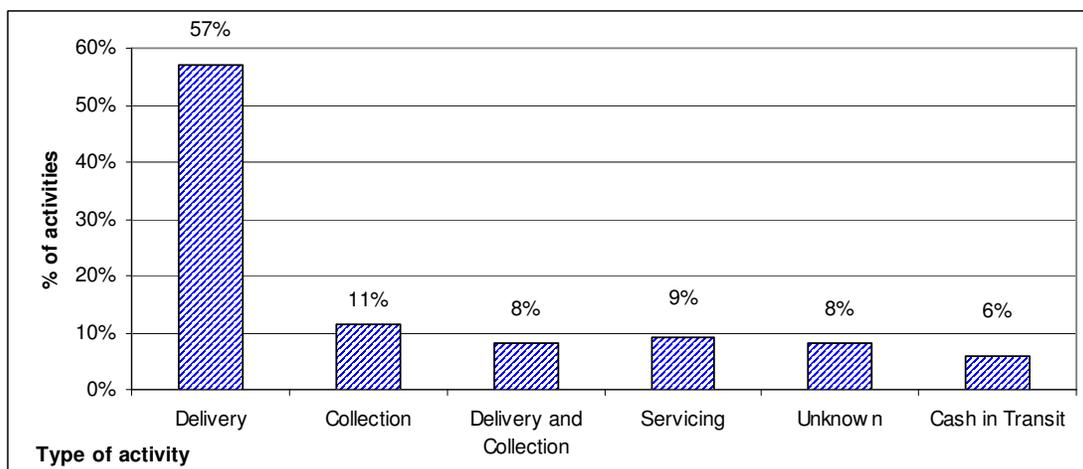
Figure 4.4: Type of activity observed on PHS

The most observed type of activity was deliveries, accounting for 57% of activity. It is interesting to note that 6% of all activity on PHS consists of cash in transit services.

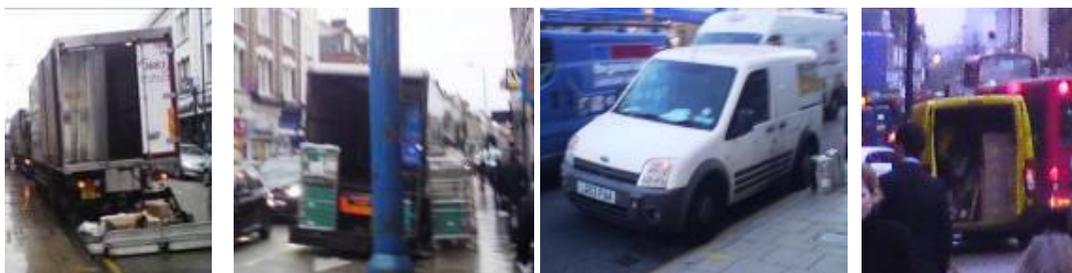
Figure 4.9: Observations of handling units observed

Table 4.9 shows the types of handling unit observed. In the majority of cases, these were loose boxes or items (40%), rather than a handling unit such as Roll Cages or Pallet Trucks. This is not surprising given the nature of the vehicles observed in activity (i.e. vans).

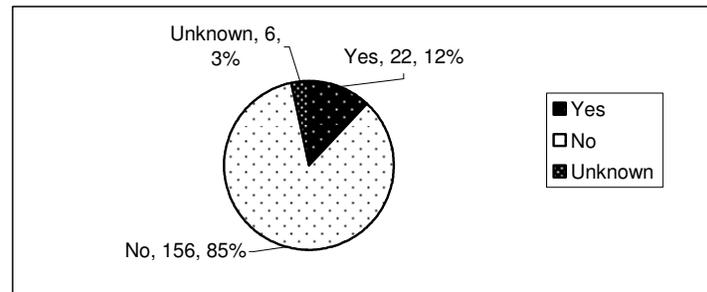
Figure 4.10: Safety Issues observed

Whilst PHS has significant amounts of traffic utilising it, including as a through route, only 22 instances of activity (12%) were recorded as having unsafe elements to them. Supporting comments relating to the unsafe practices included drivers having to cross PHS, general driver safety issues and parking on pavements and in pedestrian areas.

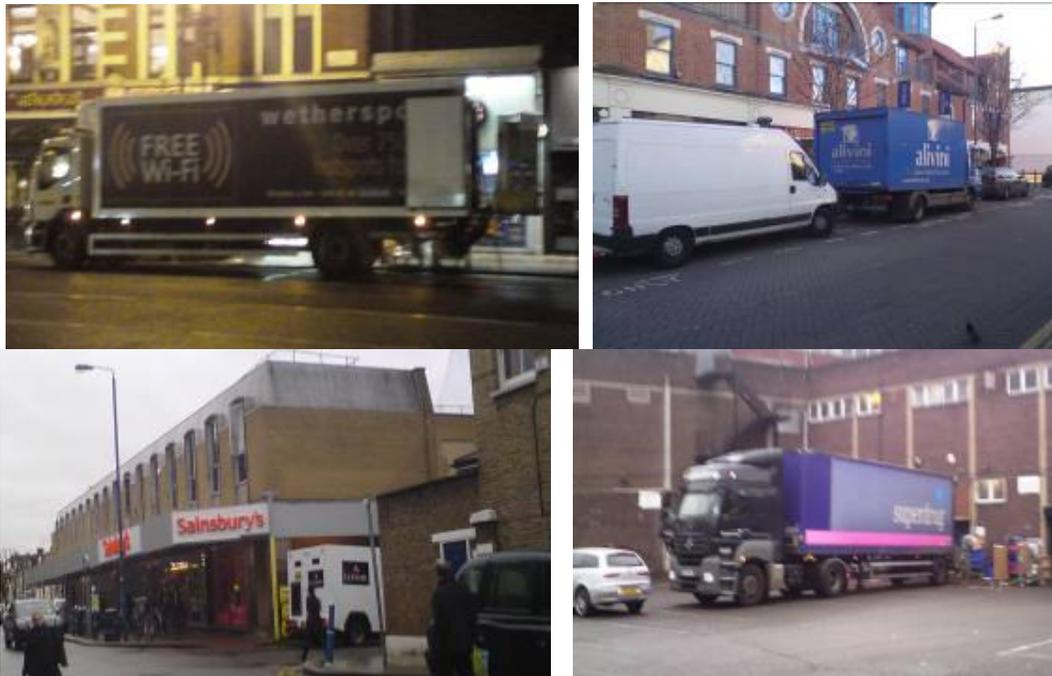
Figure 4.13: Observed use of loading facilities at Putney High Street Red Route Loading Bay (top left), Lacy Road (top right), Sainsburys (bottom left) and Superdrug (bottom right)

Of all of the activities observed, 33% of these used loading/unloading facilities. The most observed areas where loading facilities were used included Lacy Road Loading Bays, Walkers Place, Norroy Road Loading Bays and Werter Road. Loading facilities in Werter Road consisted of WHSmiths using a side loading entrance, the delivery yard at Sainsburys, and a rear access area behind Prêt a Manger. Loading/unloading facilities in Chelverton Road consisted of commercial vehicles entering the Go Ahead Depot for delivery/servicing reasons, whilst in Disraeli Road, this consisted of the service area between the library and GNC.

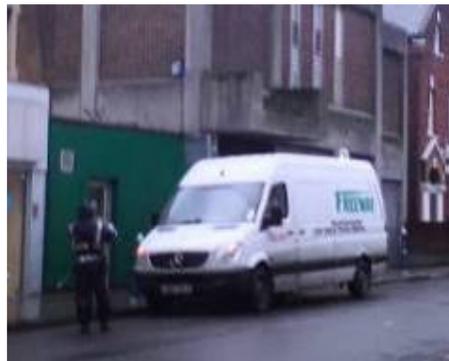
Figure 4.14: PCN being issued to commercial vehicle on Werter Road

Only 2 Penalty Charge Notices were issued over the course of the observations – these were to commercial vehicles on the middle section of Putney High Street and on Werter Road.

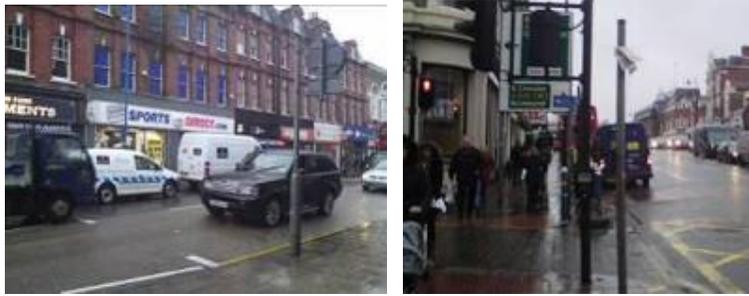
Figure 4.16: Cash in Transit

Cash in Transit activity was recorded in 11 stances of activity during the observations, all undertaken by either Loomis or Group 4 Security (G4S). It was interesting to note that in the case of Loomis, one van was immediately followed by a second, with livery on the side of the vehicle indicating that this was in conjunction with the Met Police.

As a result of the nature of cash in transit deliveries, in the majority of cases, it is not secure to use loading facilities but rather to stop to the front of premises, typically on PHS.

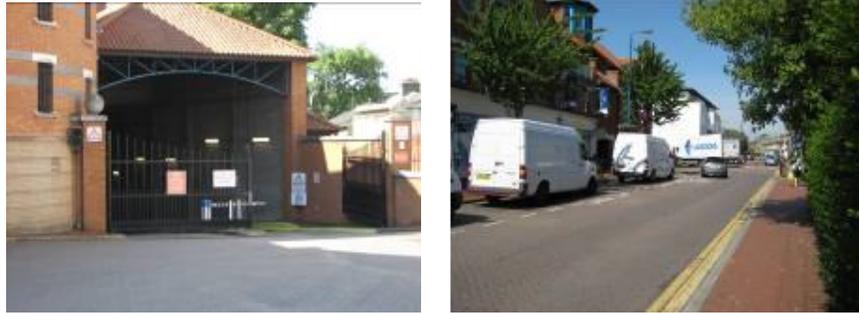
Figure 7.1: Entrance to PESC Service Yard

The Putney Exchange Shopping Centre’s vehicle entrance is located off of Lacy Road, with pedestrian entrances also off of Lacy Road, and off of PHS. There is a car park available for customers consisting of approximately 250 spaces and adjacent to the entrance to the car park on Lacy Road, is an entrance to a delivery and servicing yard.

The yard consists of 11 shared access delivery bays, 8 of which are double bays for use by larger vehicles. Vehicles wishing to access the yard first need to sign in with security at the entrance to the yard, before proceeding. The signing in sheet identifies the company that is carrying out the activity, who the activity is for, and arrival/departure times. The Centre receives approximately 10 – 20 deliveries per a day for its tenants, with Thursday the busiest day for deliveries as businesses prepare for the weekend.

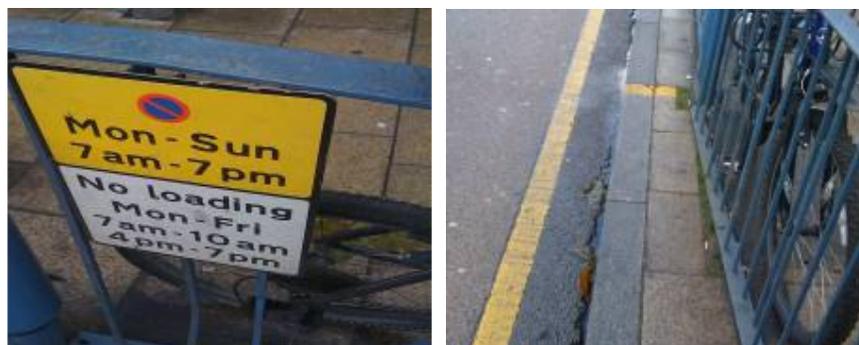
At junctions with side roads such as Chelverton, Werter, Lacy and Felsham Roads, the restrictions and road markings change to double yellow lines (or double red in the case of Norroy Road) and double pips indicating no loading at any time. In some areas the yellow lines and pips on the pavement present signs of wear and appear faded.

Figure F.1: Parking and loading restriction signage (left) and road markings (right) on the High Street

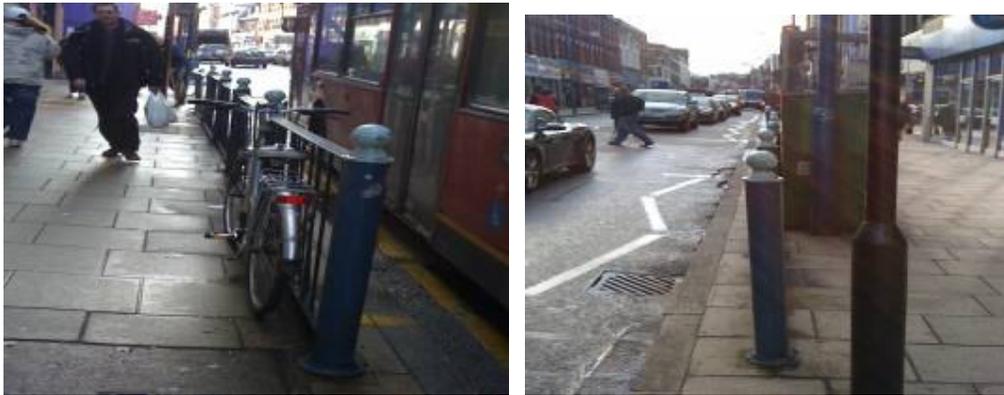
The pavements' surface along the High Street is made of paving slabs which overall are in good condition and do not appear damaged by heavy freight activity occurring on the High Street. However, the carriageway surface has cracks and potholes in close proximity to the pavements.

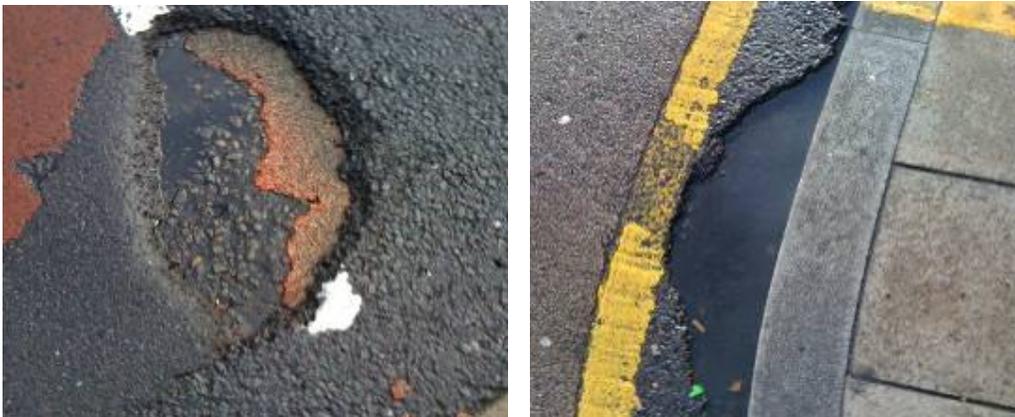
Figure F.3: Evidence of Pot holes on the High Street

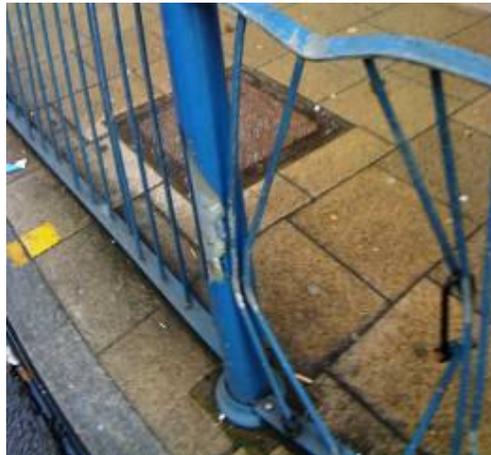
Figure F.4 Damaged railing

It is felt that freight vehicles hinder the traffic flow and disrupt vehicles travelling behind them when deliveries take place on the High Street.

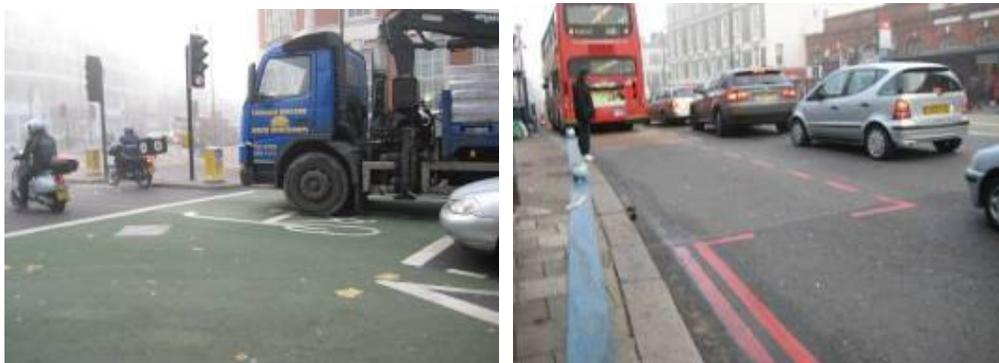
The junction of Upper Richmond Road and the High Street South West is subject to Red Route restrictions of double red lines which impose no stopping for parking or loading at any time. This junction is signalised and requires vehicles to slowdown and stop. Some bunching of traffic occurs at the junction occurs when the traffic light is red.

Figure F.5: Traffic light controlled junction of Putney High Street and Upper Richmond Road (left) and Loading bay on High Street Northbound carriageway

On the Northbound carriageway of the High Street South West there is a Red Route Loading bay whose detailed description is provided in the section E.4.

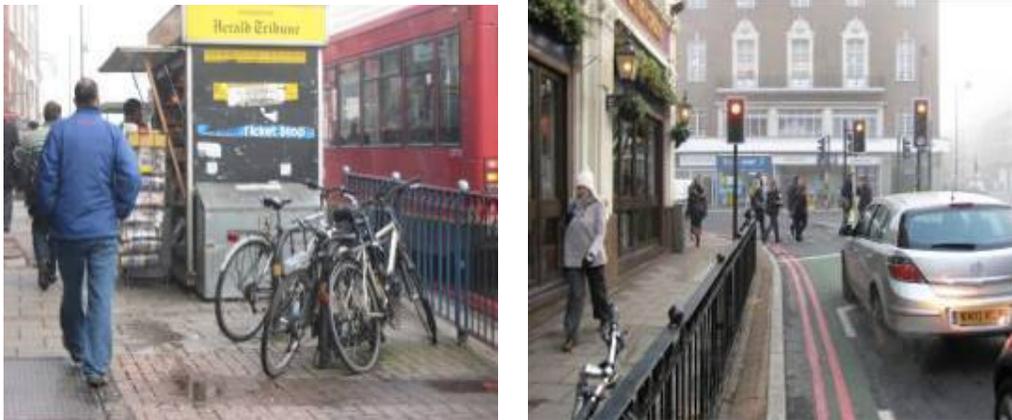
This intersection has a particular high volume of pedestrians and cyclists drawn by the interchange with public transport services, both bus and rail services located on the High Street. Cycling stands are provided on High Street South West but these are over subscribed with overspill bicycles having been observed to be parked to the

railings. Railings are present on both the High Street Southwest and Upper Richmond Road to protect pedestrians and other users from traffic.

Figure F.6: Bike parking facilities High Street Southwest (left) and the provision of railings at the junction (right)

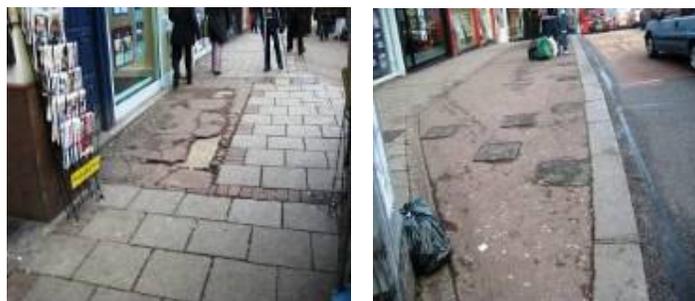
Figure F.7: Footway surface around the Red Route Loading Bay and on the High Street

The footway surfaces are made from paving slabs on both the High Street and Upper Richmond Road, and from a combination of block and tactile paving at the pedestrian crossing on Upper Richmond Road. The kerbstones around the pedestrian crossing are lowered to serve mobility requirements of disabled and wheelchair users.

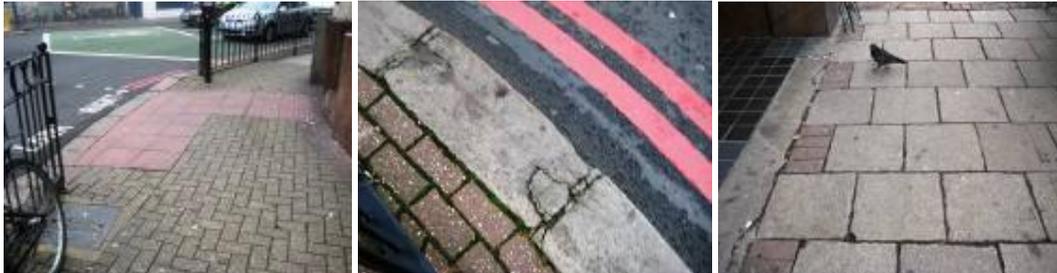
The pavement surface around some of the premises on the High Street South West has significant cracks and depressions that can cause a trip hazard for pedestrians and delivery drivers alike. The paving slabs on Upper Richmond Road are in good condition with no visible defects.

Figure F.8: Footway surface at the pedestrian crossing on Upper Richmond Road (left) and Kerbstone at the junction (centre) and Footway surface at Railway Pub (right)

On the Upper Richmond Road kerbstones are made from a durable material and look intact. However, in the corner of the junction and around the loading bay, the kerbstones present signs from kerbs overrunning and mounting. The paving slabs around the Railway pub entrance area present signs of visible grazing caused by heavy freight activities.

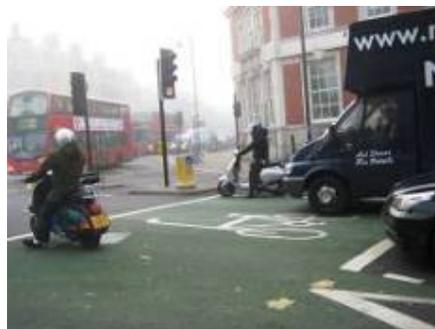
Figure F.9: Traffic flows around the junction

Freight vehicles accessing the junction come from roads which are congested with high volumes of traffic. The junction is not in the proximity of any residential areas and premises present on High Street South West and Upper Richmond Road are

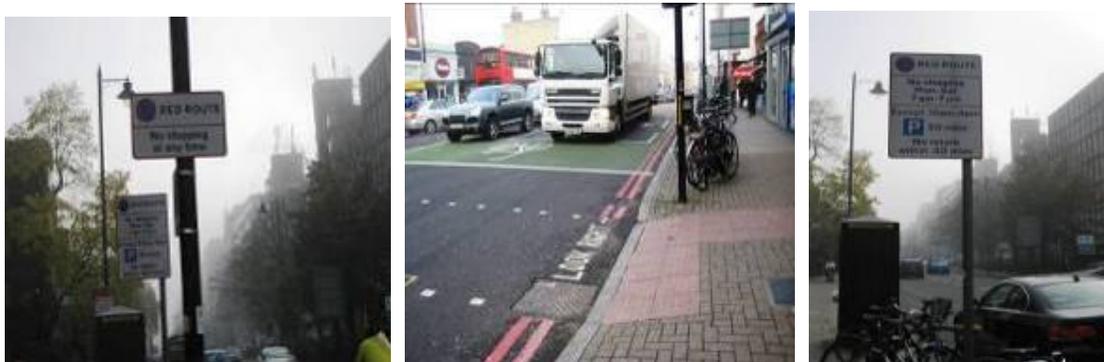
This junction is a Red Route which does not allow freight vehicles to stop at any time. Upper Richmond Road and this corner of the High Street have a high volume of traffic, with traffic lights present to manage the traffic flow and allow for pedestrian crossing. There are some parking spaces located on Upper Richmond Road North East, opposite the Warren Estate agency.

Figure F.10: Freight and traffic flows at the junction (left) and red route signage restriction on the High Street (centre) and Upper Richmond Road parking signage (right)

Where legal stopping is not allowed on the High Street, it is felt that it is most likely that freight vehicles would stop on Upper Richmond Road, with parking allowed for a maximum of 20 minutes between 10:00 – 16:00, Monday to Sunday.

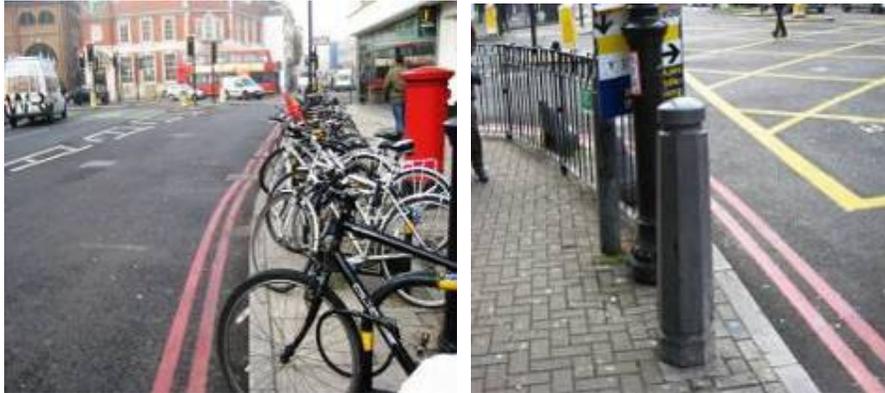
A high number of cyclists have been noticed at this junction and bike parking facilities are provided on Upper Richmond Road South East. There is no dedicated cycle path on the High Street or Upper Richmond Road for freight vehicles to interact with. Pedestrian railings and bollards are provided to protect pedestrians and other users from the freight traffic on the Upper Richmond Road North East and on the corner of the junction with the High Street.

The space available at the corner of the junction allows vehicles to turn without overrunning the kerb. However, bollards are present to prevent encroachment with pedestrians and other users.

Figure F.11: Bike parking on Upper Richmond Road (left) and Bollards at the corner of the junction

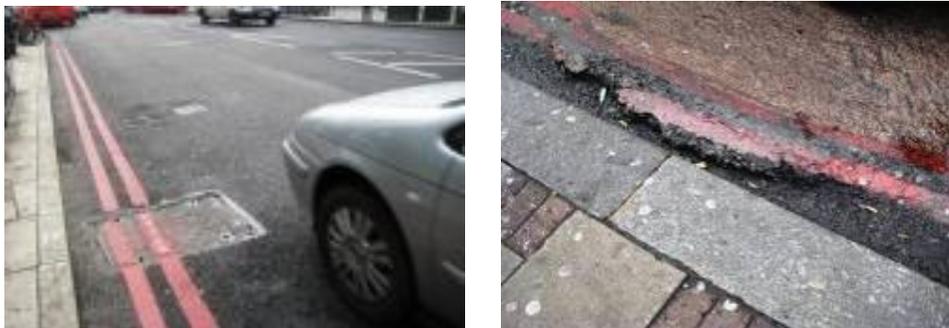
Figure F.12: Carriageway surface on Upper Richmond Road (left) Carriageway surface at the bus stop (right)

The carriageway and the parking spaces on Upper Richmond Road are in good condition with no potholes or cracks visible and are considered suitable for freight activities. There are signs that any potholes present have been covered. Undulations and flaws on the carriageway have been spotted around the bus stop on the High Street in front of the Station entrance that could present a trip hazard for pedestrians.

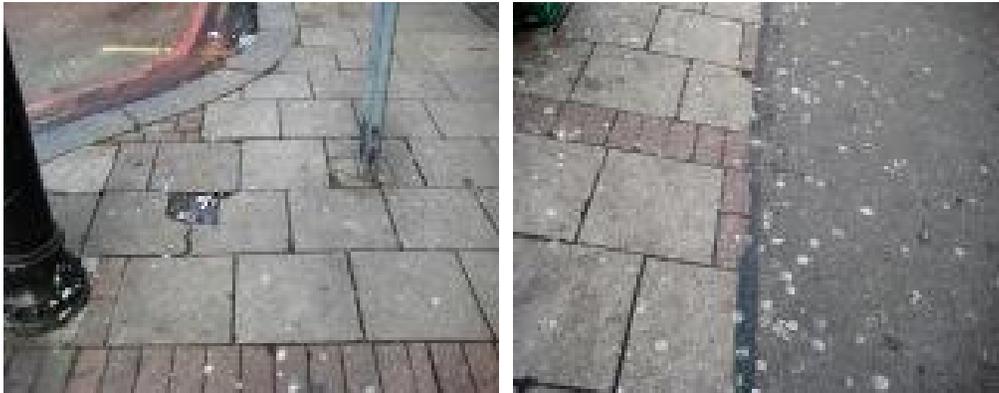
Figure F.13: Footway surface on the High Street (left) and on the Station area

The paving slabs on Upper Richmond Road are in good condition and visually attractive while those on the High Street around the bus stops are more damaged. Slabs around the waste bins have been affected by the freight activity or have parts

missing. The tarmac footway area around the railway Station entrance is free of cracks and visible undulations.

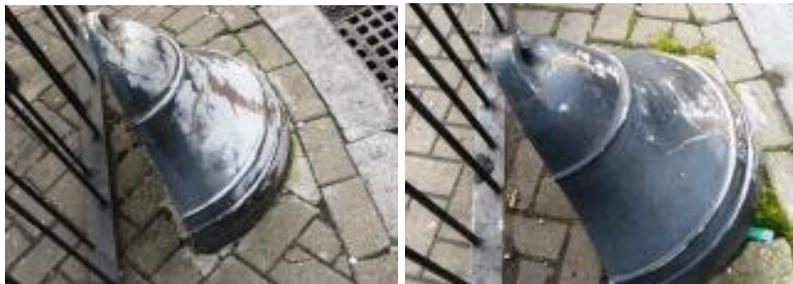
Figure F.14: Damaged bollard at the corner of the junction

In terms of vertical object strikes, the pedestrian railing, signposts and lamp posts have no significant signs of damage. This street furniture is located in an area where it is not likely to be hit by moving vehicles. However, the bell shaped bollards present at the junction between the two roads show signs of being struck to the extent that they have been uplifted.

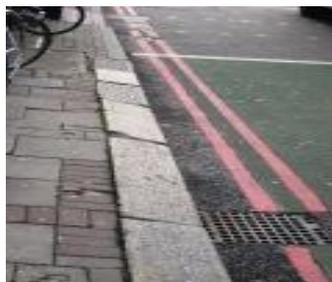
Figure F.15: Kerbstones on the High Street

The kerbstones on Upper Richmond Road appear intact while those present on the North East of the High Street section of this junction are more worn with cracked slabs.

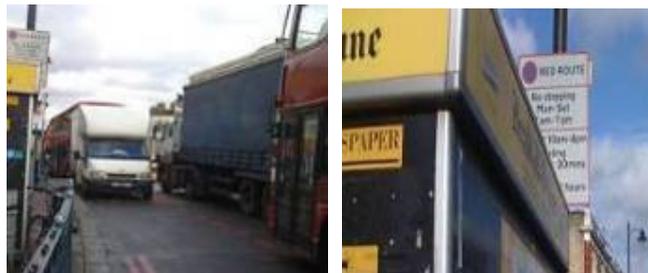
Figure F.17: Obstructed signage and Loading Bay road markings

In terms of visibility, the sign is obscured by the newsagent outlet nearby the loading bay. The loading restrictions are appropriate for majority of the adjacent businesses including the pub. Despite some wear in the bays' road markings, these remain visible.

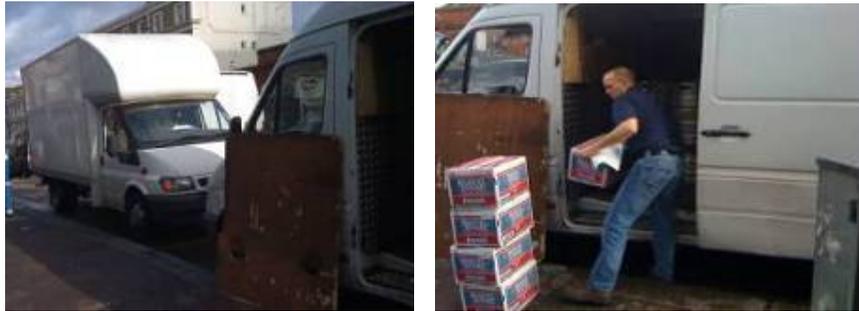
Figure F.18: Vans and delivery activity in the Loading bay

The distances to the premises likely to use the loading space is less than 40 meters, and the Railway pub, which is likely to receive heavier deliveries and barrels, is located less than 5 metres from the loading bay.

The loading bay is not of adequate size to accommodate all types of freight vehicles and disabled usage in the same time. The loading bay can only be used by one goods vehicle at a time and for larger vehicles of gross vehicle weight above 7.5t, these vehicles would not fit in the loading bay without encroaching into the bus stops. This is illustrated in Figure E.18 (left) where one vehicle is delivering while the small rigid is parked illegal on the bus lane outside the bay.

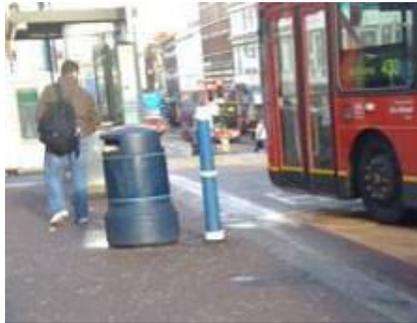
The footway area of the premises near to the bay is uneven and represents a serious trip hazard for delivery driver. The carriageway around the bay surface is from tarmac and overall is in good condition, despite some undulations in the bus lane surface.

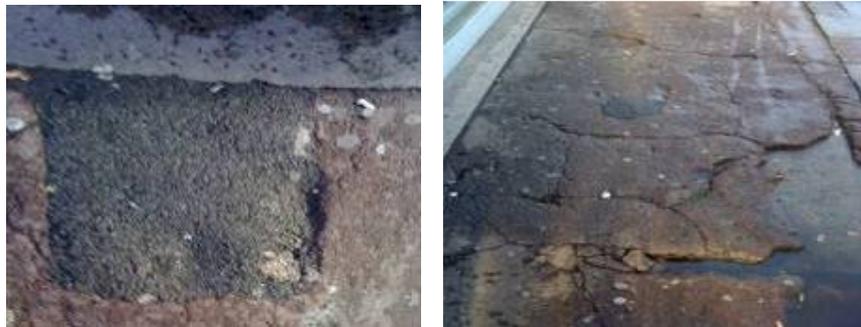
Figure F.20: Footways surface around the bay (left) and Uneven surface (right)

The footway surface around the bay is made from red tarmac and presents regular patches of black tarmac caused by the possible removal of bollards around the bay. However, one brightly contrasted bollard has “survived” next to the litter bin and the bus stop which is not likely to affect or impede the loading and unloading activities in taking place in the bay.

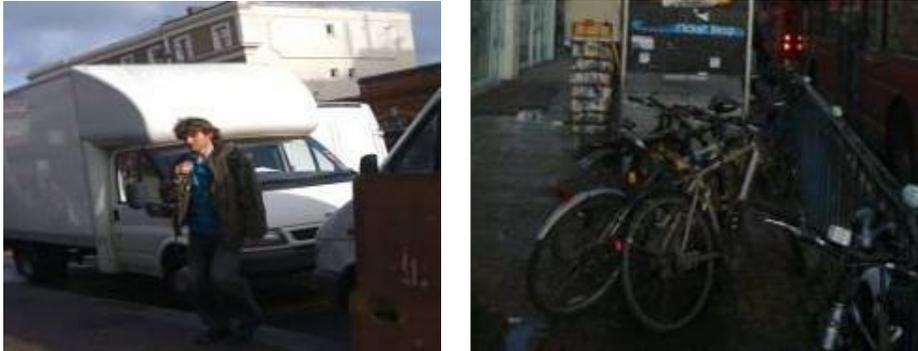
Figure F.21: Pedestrian improperly crossing the street (left) and Parked bicycles (right)

There is a high volume of pedestrians, public transport users and cyclists in this area. Bicycles are parked on the pedestrian railing at the junction between Upper Richmond Road and the High Street, as described in E.2 and E.3. Delivery vehicles can impede on the flow of the bus service at the bus stop and there is a real conflict between pedestrians that inadequately cross the High Street carriageway and delivery vehicles located in the loading bay.

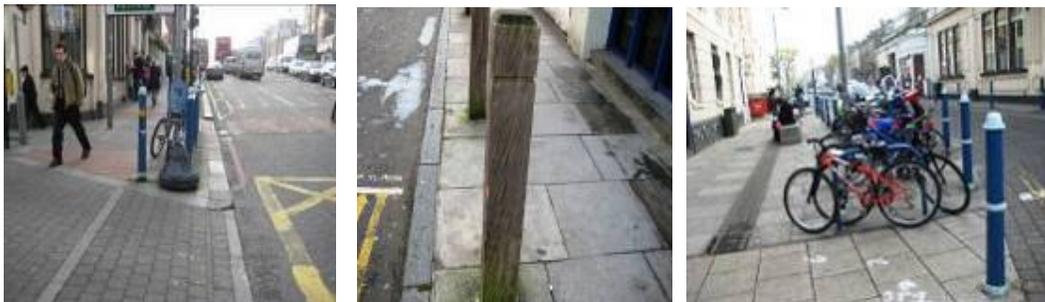
Figure F.23: Bell shaped bollard (left) Timber bollards (centre) and other bollards (right) on Disraeli Road

A bell shaped bollard is provided at the corner of Disraeli Road South East and the High Street South preventing encroachment with pedestrians and cyclists.

The timber bollards present after the Gallery outlet ensure minimum conflict between pedestrians and possible freight activity occurring on Disraeli Road.

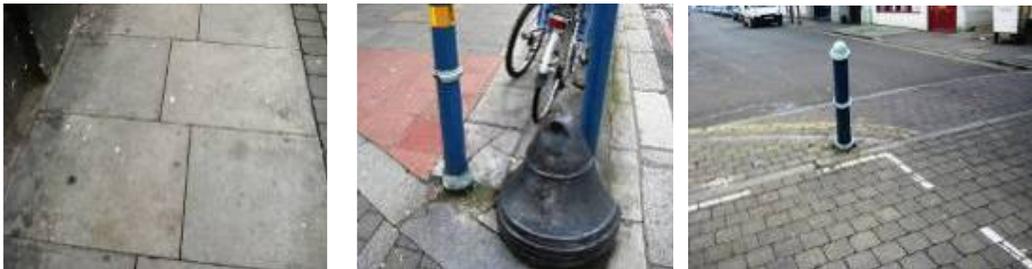
Figure F.24: Pavement slabs (left) Nudged bell shaped bollard in the corner of the junction (centre) and other bollard damage (right)

The carriageway surface is block paving and is free of defects and undulations. The footway surface is composed of a combination of paving blocks at the junction with the High Street and paving slabs along the pavement. These are in good condition and intact.

The range of bollards located on Disraeli Road appear to have been struck by vehicles previously, particularly the bell shaped bollard present in the junction with the High Street, providing some evidence of the kerb mounting.

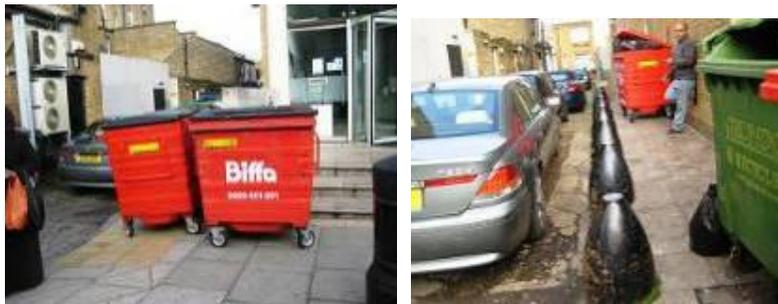
Figure F.26: Industrial waste bins stored in front of the library entrance (left) and Side servicing road on Disraeli Road North East

In front of the library's main entrance there were 2 industrial waste bins stored on the pavement. These were unaligned and restricted the footway surface available on the pavement to the library' visitors. The presence of the industrial waste bins increases the chances of encroachment between freight vehicles and pedestrians, obstructing the free flow of pedestrians on the pavement.

The servicing road by the library is used by private cars to park and to store industrial waste bins. These are stored on the pedestrian area of the servicing road and require regular waste collections. However, due to the cars parked on the side road throughout the day, waste and recycling vehicles cannot access the servicing road and complete their servicing without disrupting the traffic flow. This potentially explains why waste bins were temporarily stored by the library entrance.

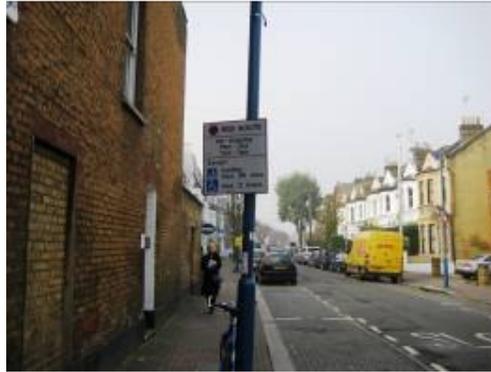
Figure F.27: Red Route sign on Norroy Road

Norroy Road is a one way street which in conjunction with the High Street is subject to red route restrictions. The red route restrictions prevent vehicles from stopping from Monday to Saturday from 07:00 to 19:00, except for loading for a maximum of 20 minutes and disabled usage up to 3 hours within the loading bay. Outside of the loading bay, there are no loading restrictions or times indicated by signage or the presence of pips. The road consists of mainly residential housing with large amount of residential parking spaces available. There are also several Pay and Display parking bays and a loading bay (see E.9)

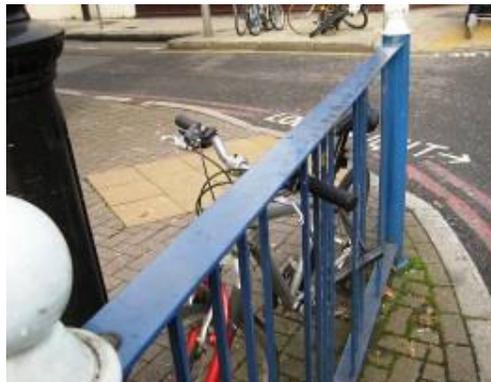
Figure F.28: Pedestrian railing the High Street in junction with Norroy Road

When the loading bay is in use, freight vehicles will circle the area until an appropriate space is found. There is no formal cycle path interaction with freight vehicles and cycles are parked by the pedestrian railings and signposts on Norroy Road South West. There are a high number of pedestrians at the informal crossing between the High Street North and South.

Pedestrian railings to protect pedestrians and potential encroachment by freight vehicles are provided on the High Street at the junction with Norroy Road South

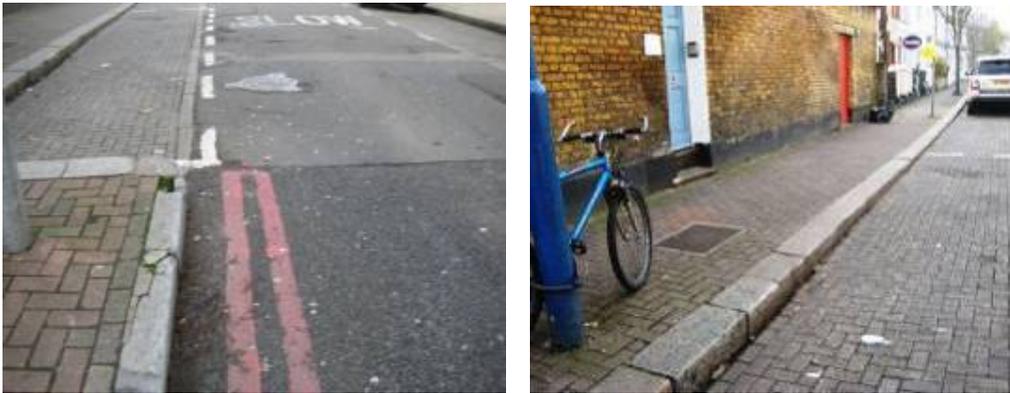
Figure F.29: Carriageway (left) and footway (right) surfaces

At the informal pedestrian crossing between the High Street North West and South West, there is good inter-visibility between pedestrians and freight vehicles. At this crossing, the kerb is lowered and the footway area provided with tactile pavement to ease wheelchair and disabled access as well as facilitating the manoeuvring of manual handling aids for loading.

The carriageway surface of Norroy Road is tarmac which has depressions and undulations, and the road markings are faded. The footway surface is paving blocks and is free of cracks and flaws.

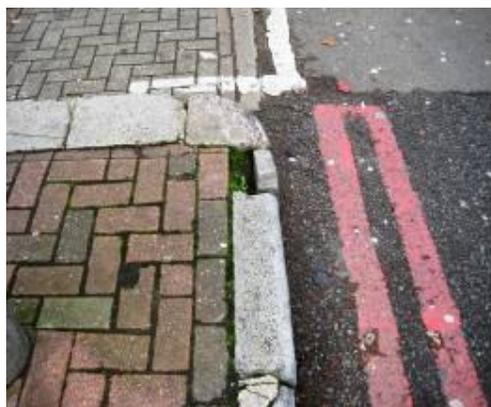
Figure F.30: Kerbstone run-over

There are no signs of street furniture being damaged by freight vehicles. However, the turn into the loading space has a tight angle and there are indications of the kerbs having been run over. At the corner between Norroy Road South West and the High Street the kerb stones have extensive cracks with parts missing which indicate heavy freight movements.

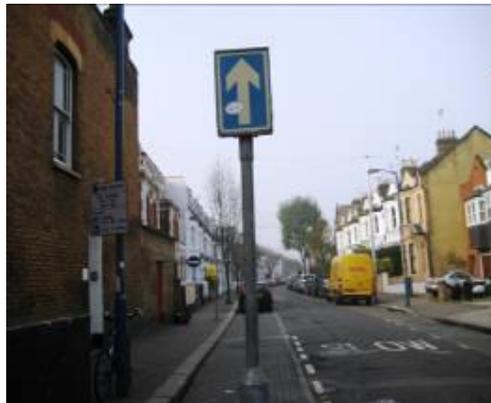
Figure F.31: Signage on Norroy Road

There are no HGV signs present to indicate the routes to the area. The one way street Norroy Road is adequately signposted. The red route restrictions are signposted at a location where the sign is visible.

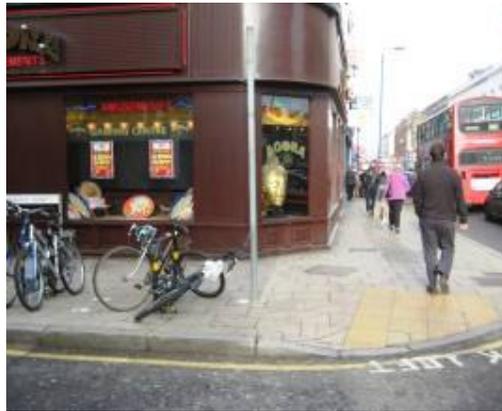
Figure F.32: Norroy Road North West and High Street junction

This section of Norroy road is part of the one way street that can only be accessed from the High Street. This section of Norroy Road is subject to single yellow line parking restrictions, with no loading restrictions identified by signage. These and the road markings on the road are slightly worn out.

There is no cycle path that freight vehicles have to cross and the road has to be shared between vehicles and other road users. Cycling parking stands and pay and display parking spaces are provided along Norroy Road North West.

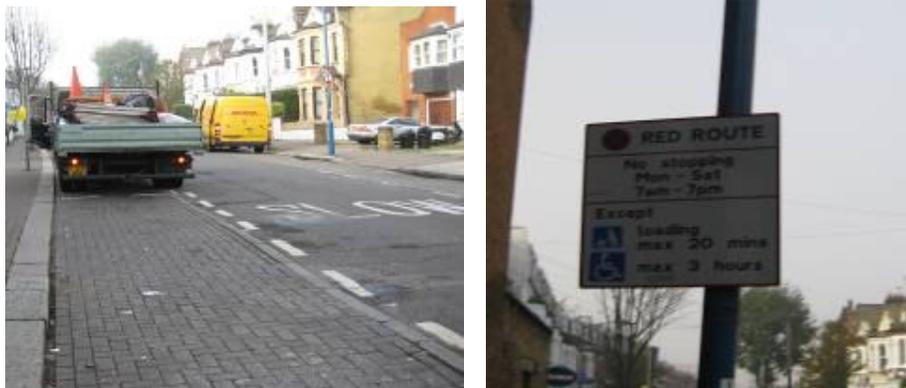
Figure F.33: Loading bay signage (left) and road markings (right)

The loading bay is signposted as a red route loading bay with mixed usage for loading and unloading activities up to 20 minutes and for disabled parking up to 3 hours. However, the faded road markings of the loading bay are not in sync with the red route restrictions indicated on the signpost. In terms of legality of the signage, loading sign does not match the road markings.

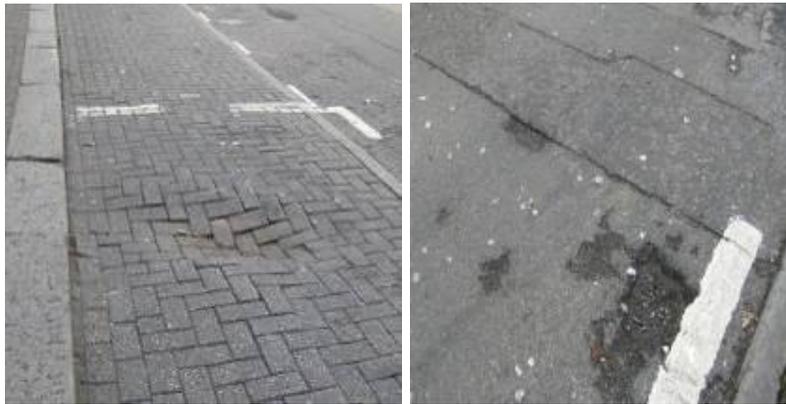
Figure F.34: Footway surface (left) and carriageway (right) in the bay

The footway surface around the loading area on Norroy Road South West is made of paving blocks which do not have any visible cracking or undulations resulting from freight activities.

However, the footway surface of the loading bay itself presents depressions. The carriageway around the bay area is made of tarmac and has potholes and other uneven areas, although these are not likely to be a trip hazard for the delivery driver or hinder the usage of manual handling aid equipment.

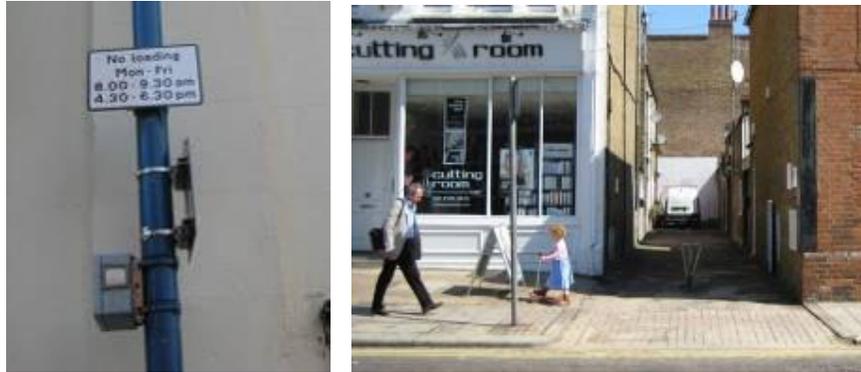
Figure F.35: Restrictions on Chelverton Road (left) and limited access to rear servicing area (right)

Access to the servicing area behind Costa Coffee is blocked and the loading activity cannot take place away from Chelverton Road.

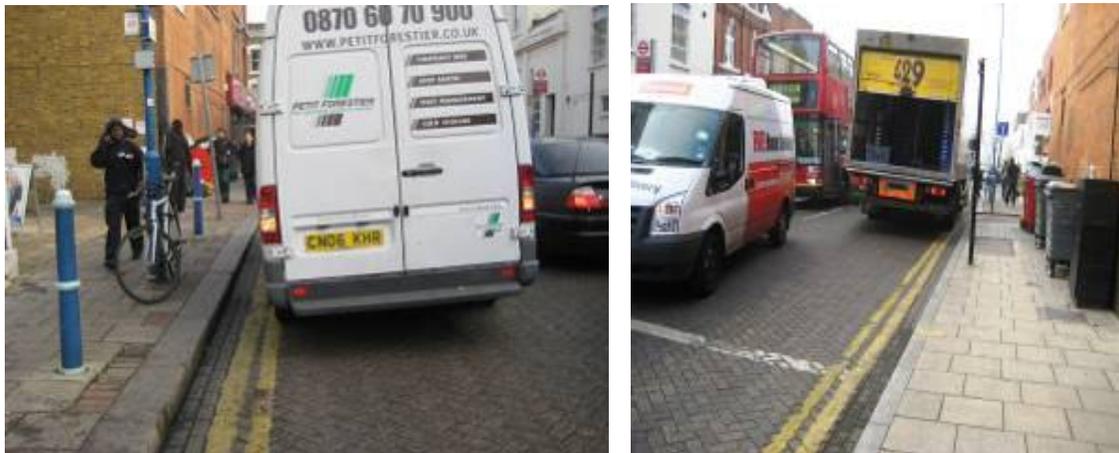
Figure F.36: Vehicles unloading on Chelverton Road and blocking the traffic lane

Freight vehicles carrying out loading/unloading activities on this side of the road tend to disrupt the traffic flow as the buses and other road users cannot easily drive past them.

Industrial waste bins from 2 different waste collection companies are stored on the pavement on Chelverton Road. This might trigger more regular collections/servicing and limit the footway available to pedestrians (women with prams etc) when freight activity takes place on Chelverton Road North West.

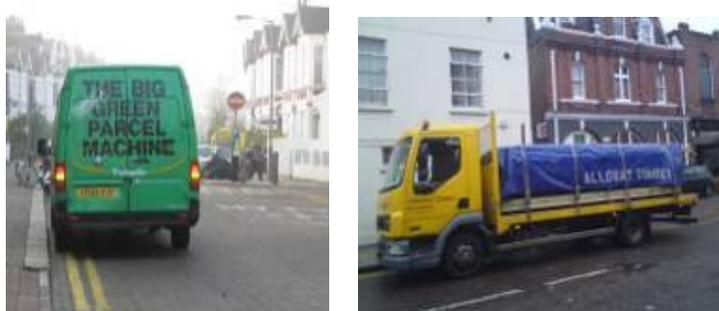
Figure F.38: Deliveries carried out on Chelverton Road South West

This carriageway gets blocked by vehicles overtaking freight vehicles stopped on Chelverton Road North West, resulting in short time congestion. The majority of freight vehicles can find a suitable place to stop without entering the main residential area on Chelverton Road.

Again, industrial waste bins are stored on the pavement, indicating regular servicing and restriction of the footway surface available for pedestrians.

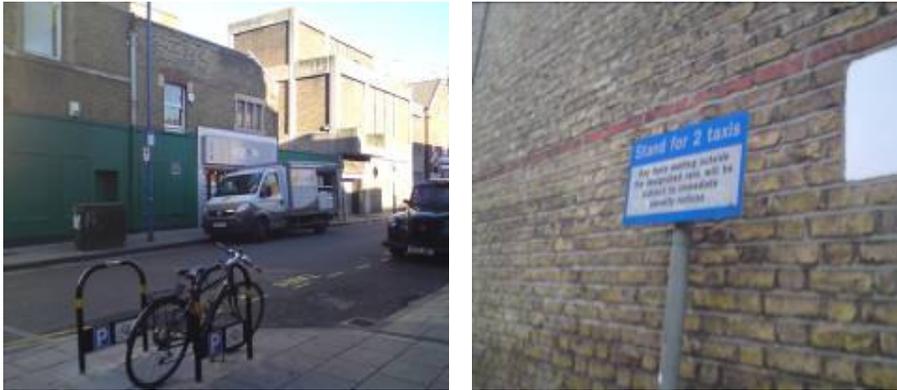
Figure F.39: Provision for taxis on Werter Road

At the western end of Werter Road, on the South Eastern side of the road, is a taxi rank, set aside from the traffic flow. The taxi rank has space for two vehicles. Towards the eastern end of Werter Road are residential, disabled and pay display car parking bays.

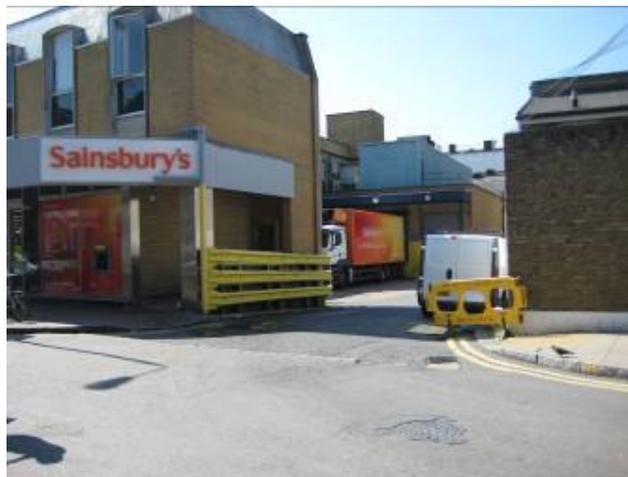
Figure F.40: Provision for loading at Sainsburys on Werter Road

Deliveries and servicing for Sainsbury occur in the interior delivery yard and away from the junction with the High Street. Rear access of some premises such as Prêt à Manger can also be accessed from the area to the west of Sainsbury's delivery yard.

However, some congestion and bunching of vehicles is caused by vehicles waiting to access the High Street.

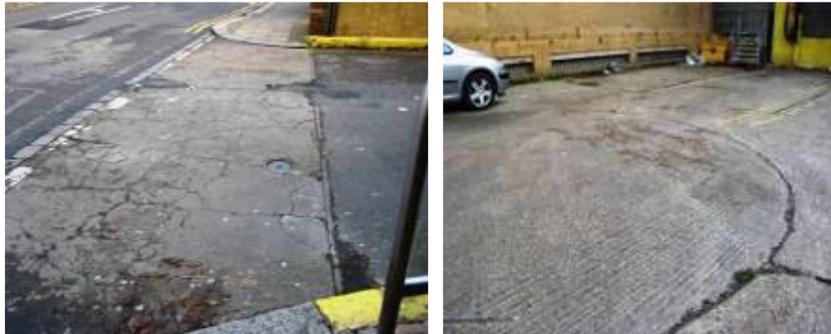
Figure F.41: Turning into the delivery yard at Sainsburys (left) and surface within the yard itself (right)

The carriageway surface presents overall cracks and undulations particularly in the junction with Sainsbury's loading yard where the surface has depressions and patches of due to road works.

However, the main loading activity occurs inside the interior yard and is unlikely to affect health and safety of the driver, or the manoeuvrability of the loading handling aids. It should also be noted that the delivery yard is not the responsibility of the London Borough of Wandsworth, but that of the land owner.

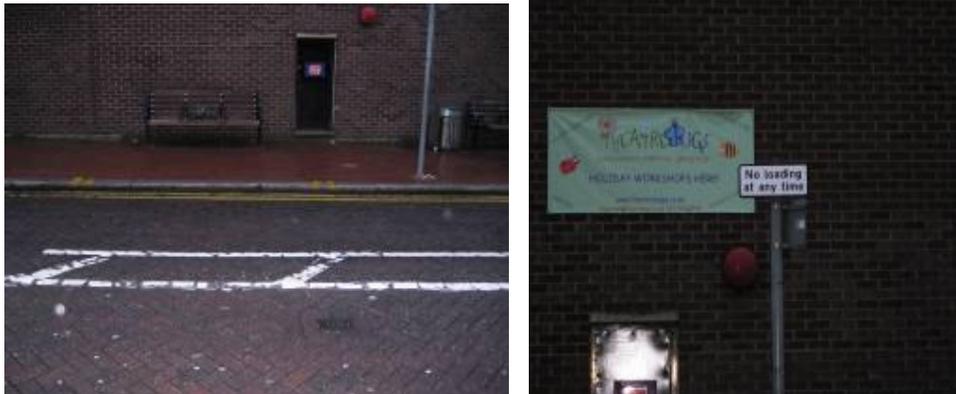
Figure F.43: Double yellow lines and restrictions on Lacy Road South West

This section of Lacy Road is provided with double yellow lines and double yellow pips. The restrictions are signposted and they indicate no loading at any time.

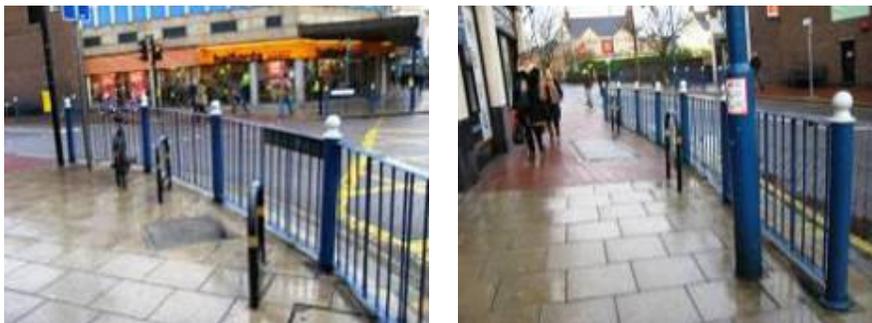
Figure F.44: Pedestrian railings and cycle parking (left) and footway service (right)

Brightly contrasted railings to protect pedestrians from encroachment of vehicles into the pedestrian environment are provided at the junction of Lacy Road and the High street, and along Lacy Road itself.

The design and layout of the junction allows vehicles to turn without significantly overrunning the kerbs, which apart from one kerbstone appear to be intact and in good condition.

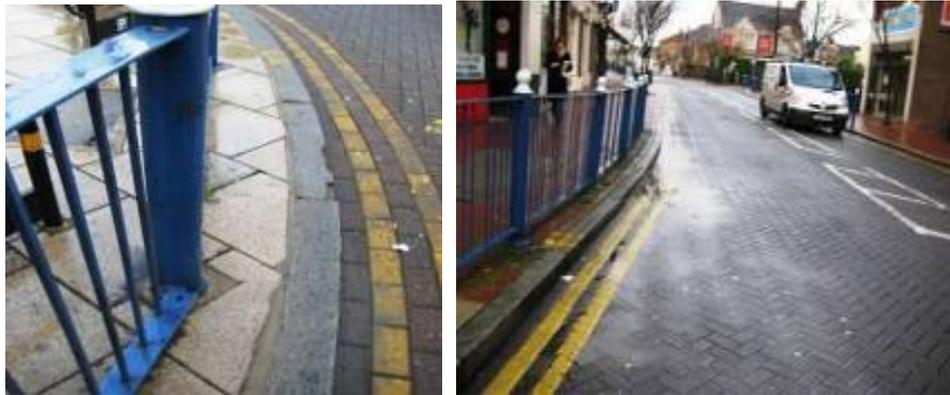
Figure F.45: Dropped Kerbstones (left) and Carriageway Surface (right)

The traffic lights and the pedestrian railings ensure complete separation between the pedestrian environment and the road users, as at this junction there is a high volume of pedestrians and cyclists with the entrance to the Putney Exchange Shopping Centre nearby on the High Street. At the pedestrian crossing the kerbs are dropped and provided with tactile paving to facilitate the mobility of the wheelchair users and other manual handling equipment likely to be used for deliveries.

The carriageway surface is made of paving blocks and there are no visible cracks, but undulations are present towards the pavement increasing the risk to pedestrians from the spray of water.

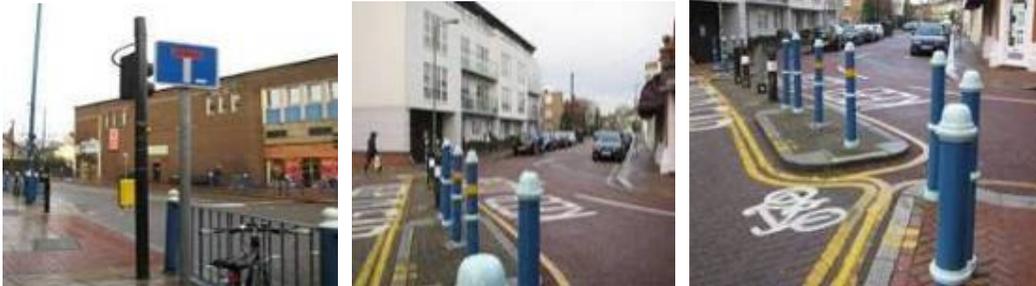
Figure F.46: Signage to Western End of Lacy Road (left) and No Access to Residential Area (centre and right)

There are no HGV or freight signs indicating the access route to the five loading bay or to the goods entrance for the shopping centre. This could be partly due to the presence of the residential area along the Lacy and Mascate Road, although it should be noted there is no through access via Lacy Road.

The western end of Lacy Road is correctly signed as a cul-de-sac, as vehicles' access towards the residential part of Lacy Road is closed.

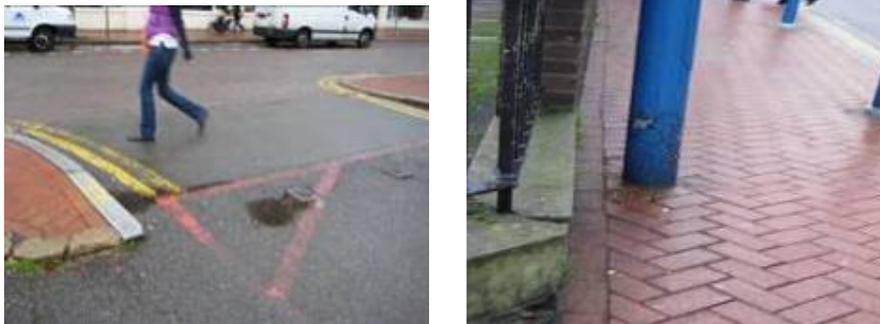
Figure F.47: Tight turn into Walkers Place from Lacy Road (left) and Vertical Strike Damage (right)

The design and layout of the junction of Lacy Road and Walkers Place has a tight radius and there are signs of the kerbs being overrun, carriageway damaged and road markings wear caused by freight vehicles.

In terms of vertical objects strike the lampposts and bollards have signs of being nudged by chains used for parking bicycles rather than by freight vehicles.

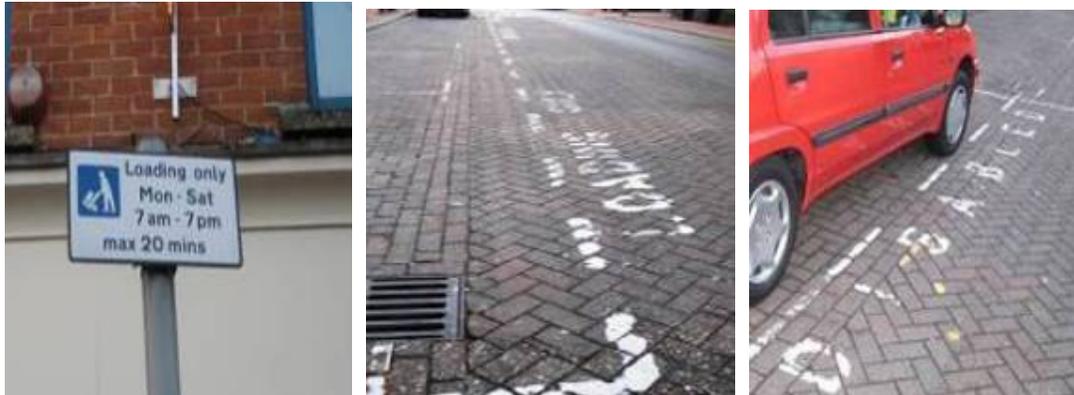
Figure F.48: Loading bays road markings (left) and restrictions (centre) and Disabled Parking Bay provision

19:00 for a maximum 20 minutes. Two dedicated parking spaces for disabled are provided further on Lacy Road South West.

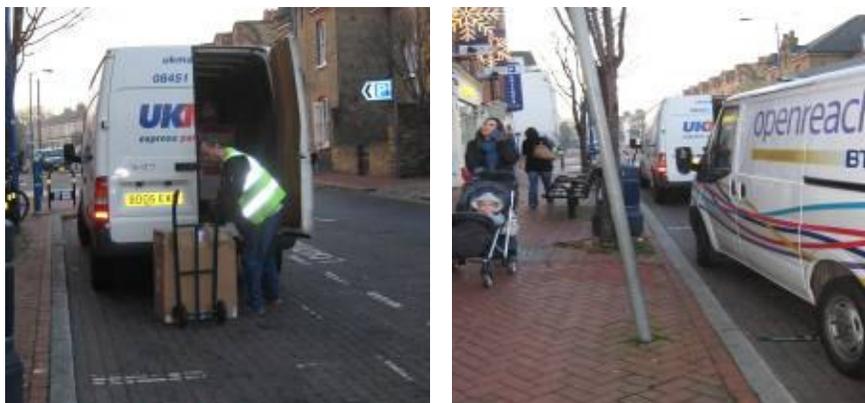
Figure F.49: Delivery activity observed

Used individually, the loading bays are not large to accommodate all types of freight vehicles including articulated vehicles. The loading spaces are suitable for all types of vehicles likely to use them if there are used together/combined as a large loading bay.

There is sufficient space to manoeuvre into/out of the loading bays and vehicles are not required to reverse into the facilities. In some cases, vans have been noted mounting the kerb. When leaving the bays, freight vehicles have been observed reversing or turning around at the Western end of road on Lacy Road, towards the goods entrance to the shopping centre.
