Putney High Street Delivery and Servicing Study

Final Report

**South London Freight Quality
Partnership**

February 2011

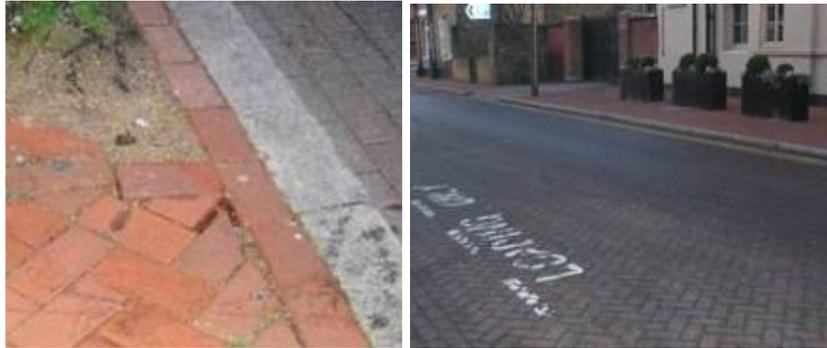
Figure F.50: Footway (left) and carriageway (right) surfaces

The footway surface in the loading facilities is made of paving blocks and is adequate in strength for heavy loads with no undulations or defects caused by freight activities.

The existing street furniture (bench, litter bins, kerbs) and the signpost are intact and do not appear to be located in areas where they are likely to be hit by freight vehicles. However, one paving block near the loading bays seems to have been damaged by heavy freight activity in the loading bay.

The footway surrounding the loading area has no camber or uneven surfaces and the most direct routes to the premises nearby are suitable for the use of manual handling aids.

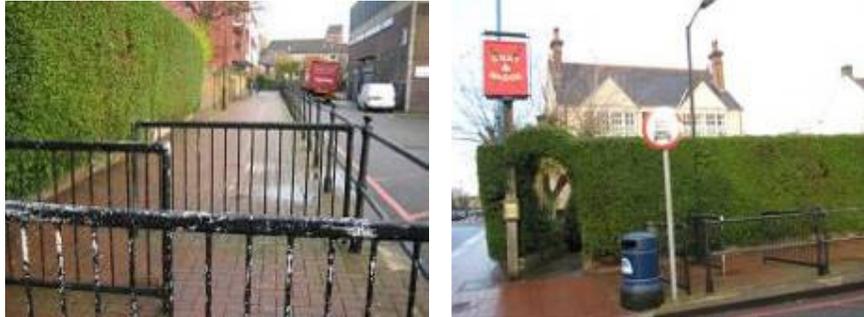
Figure F.51: Pedestrian pavement on Northwest side of Walkers Place (left) and Access Restrictions (right)

The footway surface of the pavement for pedestrians is made of paving blocks, is in good condition overall and the railings ensure complete separation between the pedestrian environment and the goods vehicles. However, on the footway surface there are visible undulations that have no impact and do not hinder the pedestrian movements.

No motor vehicles are allowed in the area and a mandatory 5 miles speed limit is indicated by the signage at the entrance to Walkers Place from Lacy Road. The junction of Walkers Place and Lacy Road is marked with slightly worn out double yellow lines and double pips

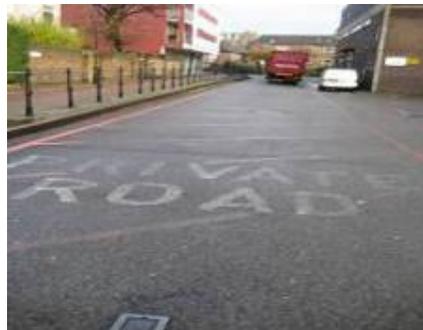
Figure F.52: Walkers Place Road Markings

The service road is with a red box and “private road” marking indicating no stopping. These road markings are faded and worn out due to the frequent freight movements on this road. However, despite this, goods vehicles have been observed (in both the Observations and FERS audit) stopping to make deliveries and collections by the goods entrance to TK Maxx blocking the exit unto Felsham Road, and to the residential/office buildings.

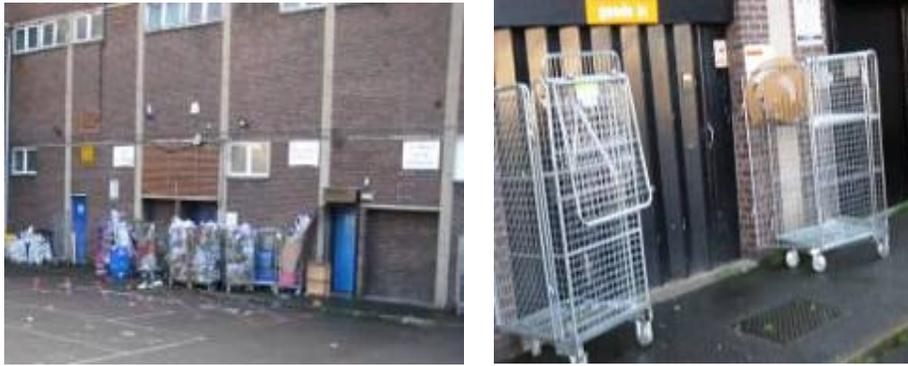
By the loading bay and Superdrug goods entrance roll cages with recycling and tote boxes are stored temporarily, next to the goods entrance. The roll cages are not aligned and could cause trip hazards, as well as hindering loading activity. Packaging is also located outside of the roll cages, giving an “untidy” look to the loading bay.

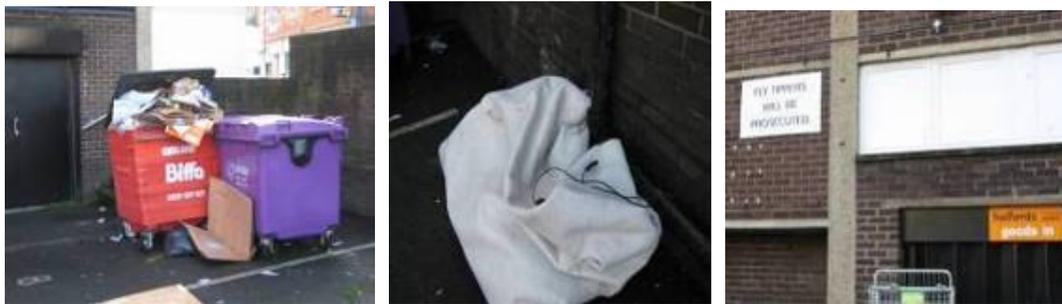
Figure F.54: Unaligned industrial waste bins (left), perceived fly tipping (centre) and signage (right)

By Halfords' goods entrance another two unaligned empty roll cages were temporarily stored at the time of the audit. Industrial waste bins were stored in the far North East corner of Walkers Place in a parking space. These were also unaligned and one of them was abandoned on the carriageway, which could have affected freight vehicles movements and blocked the access to Halfords' entrance, creating health and safety risks.

The industrial bins are hazards for both deliveries and delivery staff. The industrial bins are stored next to some steps and a second pedestrian exit onto the Lacy Road. Walkers Place North East is unlikely to be used by pedestrians or cyclists but car parking spaces are present, with drivers and passengers accessing vehicles.

It is also felt that despite the warning signpost against fly tipping, instances of this occur, with domestic waste being abandoned next to the industrial waste bins at the time of the audit.

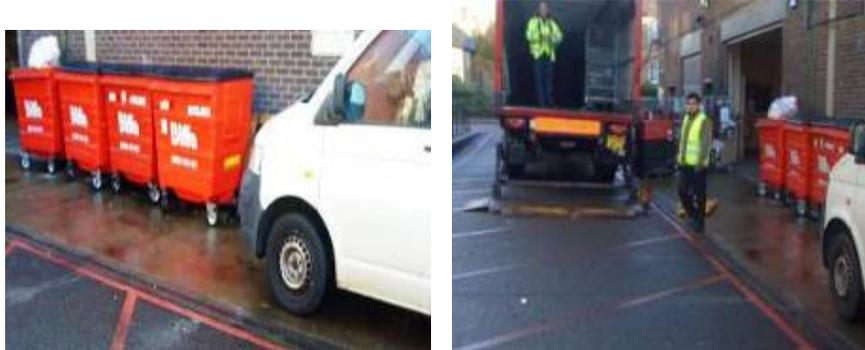
Figure F.55: Delivery activity at the North end of Walkers Place

Despite the road markings on the road, articulated vehicles stop in front of the TK Maxx goods entrance blocking the exit way unto Felsham Road. Additionally, it was observed that despite multiple parking spaces available on Walkers Place, light goods vehicles stop on the pavement at the North end of Walkers Place towards Felsham Road.

More industrial waste bins are stored on the footway area by the entrance, but there are aligned not hindering the Figured loading activity. The footway surface available at TK Maxx slightly slopes to facilitate the manoeuvring of wheeled loading equipment;

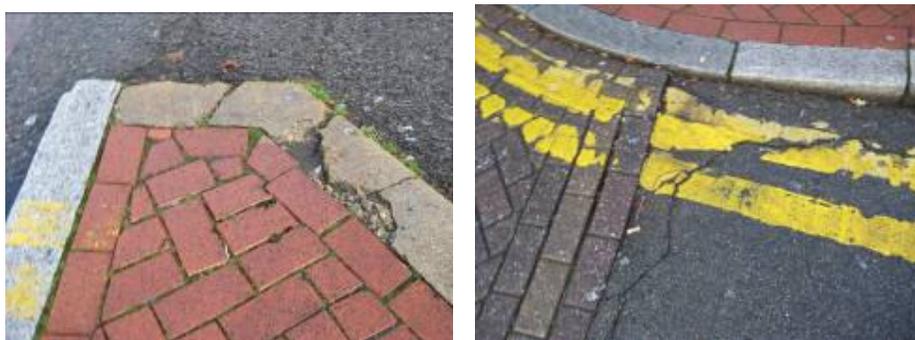
The footway and carriageway surface at the junction with Felsham Road appears damaged by heavy freight activity and goods vehicles mounting the kerbs. One bar is missing from the pedestrian railing provided to prevent the encroachment between the freight activities and pedestrian movements in junction with Felsham Road.

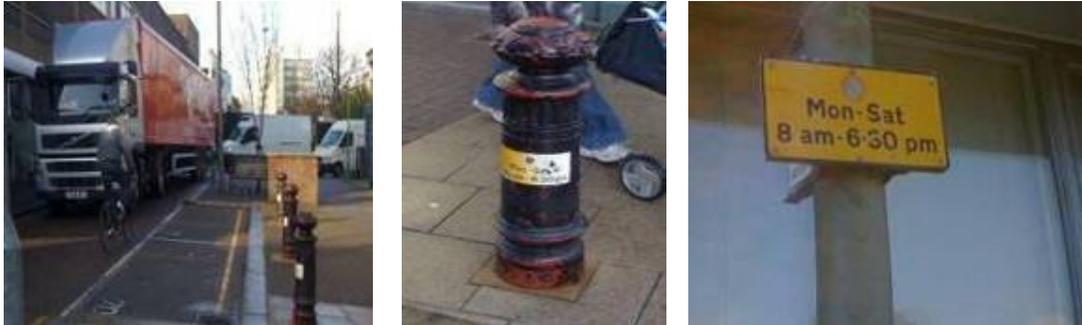
Figure F.58: Congestion from loading activity (left) and loading restrictions (centre and right)

The main commercial premise on Felsham Road is Barclays Bank, located at the junction of the High Street and Felsham Road on the South West side of Felsham Road. The exit way from Felsham Road onto the High Street is narrow and when servicing activities take place at the Barclays Bank, vehicles cannot pass by the vehicle. During the FERS audit, a G4S van was observed blocking traffic and causing disruption and congestion whilst carrying out Cash in Transit activity.

At the junction of Felsham Road and Walkers Place, where there are nearby residential properties, the loading restrictions are for no stopping Monday to Saturday 08:00 to 18:30. As you go East along Felsham Road, on the North West side, restrictions are provided through single yellow lines and single pips which restrict vehicles from waiting and loading between 07:30 and 18:30.

At the junction with the High Street, double yellow lines indicate that stopping is prohibited 24 hours a day, seven days a week. The waiting restriction signs are displayed on the bollards located on the North West of the road; these are not visible from angles to the passing traffic and can be easily overseen.

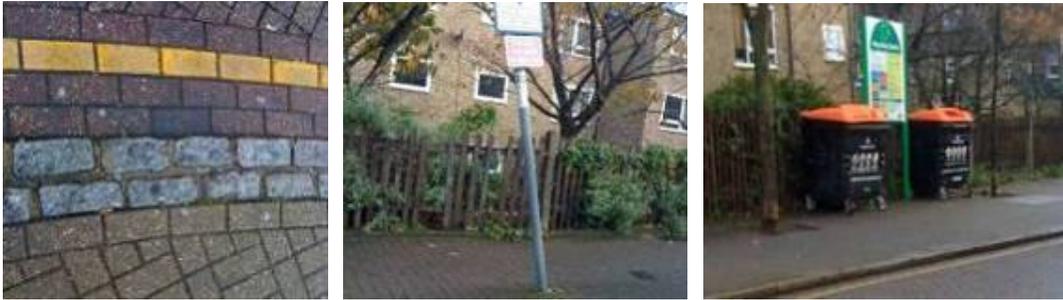
Figure F.59: Kerbstones at the junction of Felsham Road and Weimar Street (left), damaged signage (centre) and recycling facilities (right)

At the junction of Felsham Road and Weimar Street, the kerbstones are made from double granite stones and are different from the kerbstones used at the junction with the High Street. Both type of kerbstones are made from durable materials and appear in good condition.

Pay and display bays are provided on both sides of Felsham Road and recycling facilities are located on Felsham Road North West, near to residential properties. These facilities require regular servicing. The pay and display signpost nearby the recycling facility has been damaged by heavy goods vehicles' movement to the extent of being uplifted from the ground. The kerbstones around the recycling bins show signs of grazing caused by heavy freight activity.

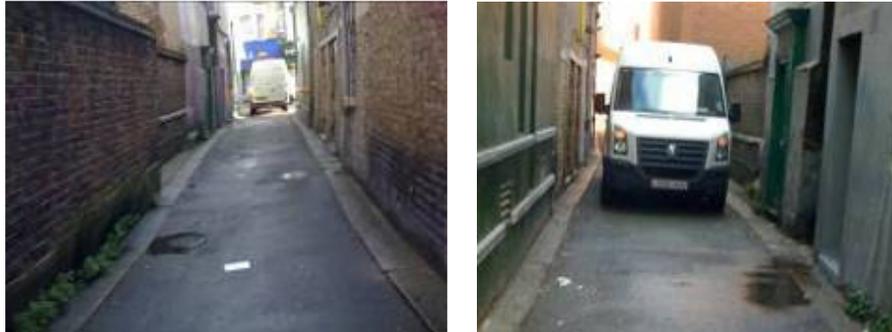
Figure F.60: Views of Jones Mews

The road is only wide enough for one vehicle, and as such is not wide enough to accommodate passing vehicles. The HMV goods entrance is located at the Northern section of the “L” shape and during Business interviews the HMV manager indicated that when one vehicle stops, they cannot bring the goods in via the service road.

The maximum size of vehicle that can access the road is a 2 axles vehicle, and it is felt that larger 2 axle vehicles would not fit along this road.

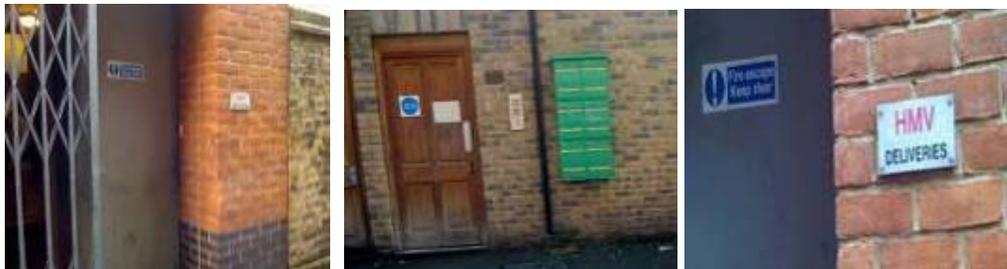
Figure F.61: Letter boxes (left) and HMV goods entrance (centre and right)

It was noted that a few premises had letterboxes on the East side of Jones Mews, and several industrial bins were stored on the ground indicating regular waste and mail service. The footway surface is made of tarmac and has potholes and cracks.
