# Lee Business Area - Delivery and Servicing Plan (DSP)

## Report

**The London  
Borough of  
Lewisham**

**March 2011**

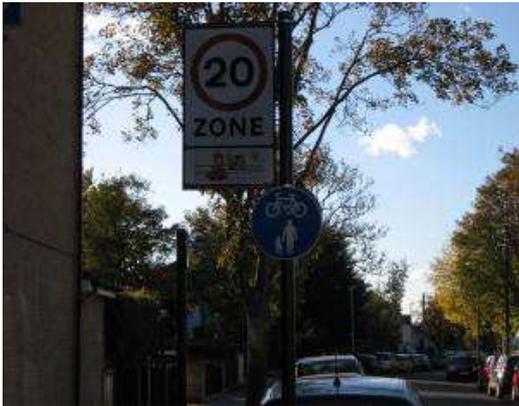
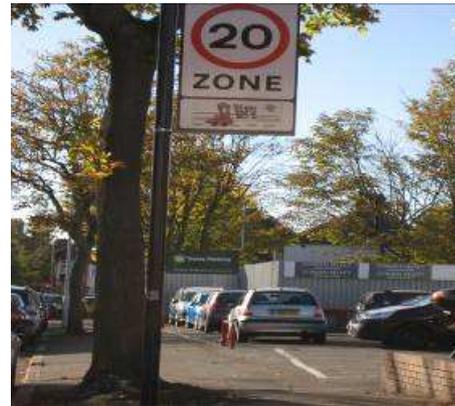
**Figures E.3 (a) and E.3 (b): 20 mile zone restriction signage**

After a few yards in from the junction with Burnt Ash Hill, Holme Lacey Road is signposted as a 20 mile per hour zone shown in figures E.3 (a) and E.3 (b).

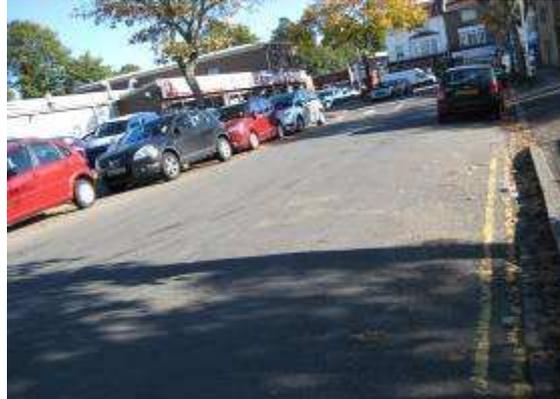
**Figure E.10: Speed hump on Holme Lacey Road**

A speed hump (figure E.10) is provided on the carriageway in front of the Citroën garage side entrance to diminish the speed at which vehicles travel.

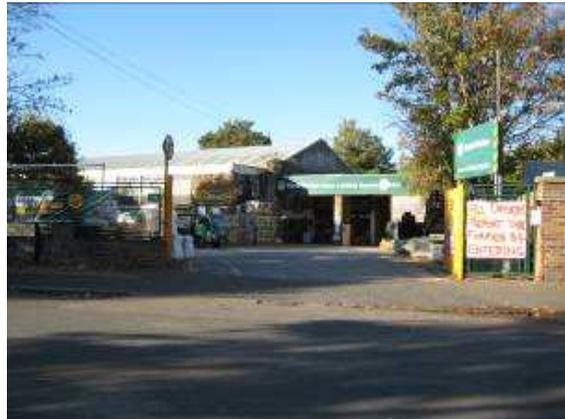
**Figure E.12: Travis Perkins service yard entrance**

The next feature on the North side of Holme Lacey Road is the entrance to Travis Perkins (figure E.12). Travis Perkins has a service yard for delivery and collection of goods vehicles. Numerous freight vehicles were observed entering and exiting the yard, including those with Travis Perkins livery name. The gates open at 07:30 in the morning and close at 17:00 in the afternoon.

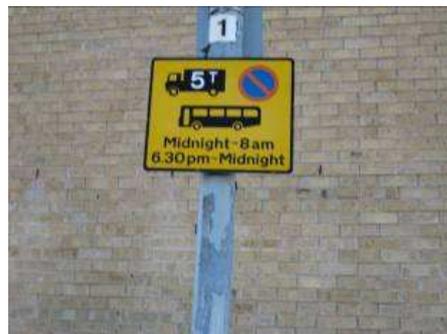
**Figure E.14: Signpost indicating freight vehicles restrictions**

On Holme Lacey Road South side the signage (figure E.14) indicates no waiting between midnight and 8a.m. and between 6.30 p.m. and midnight.

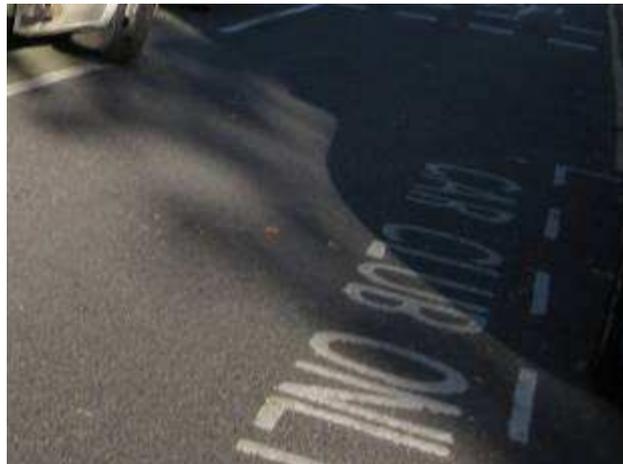
**Figure E.15: Car club parking space**

Parking spaces for car club members (figure E.15) are provided on this side of Holme Lacey Road, which also accommodates more car parking.
